## International Journal of Surgery Case Reports

# Inadvertent insertion of hearing aid impression material into the middle ear: Case report and implications for future community hearing services

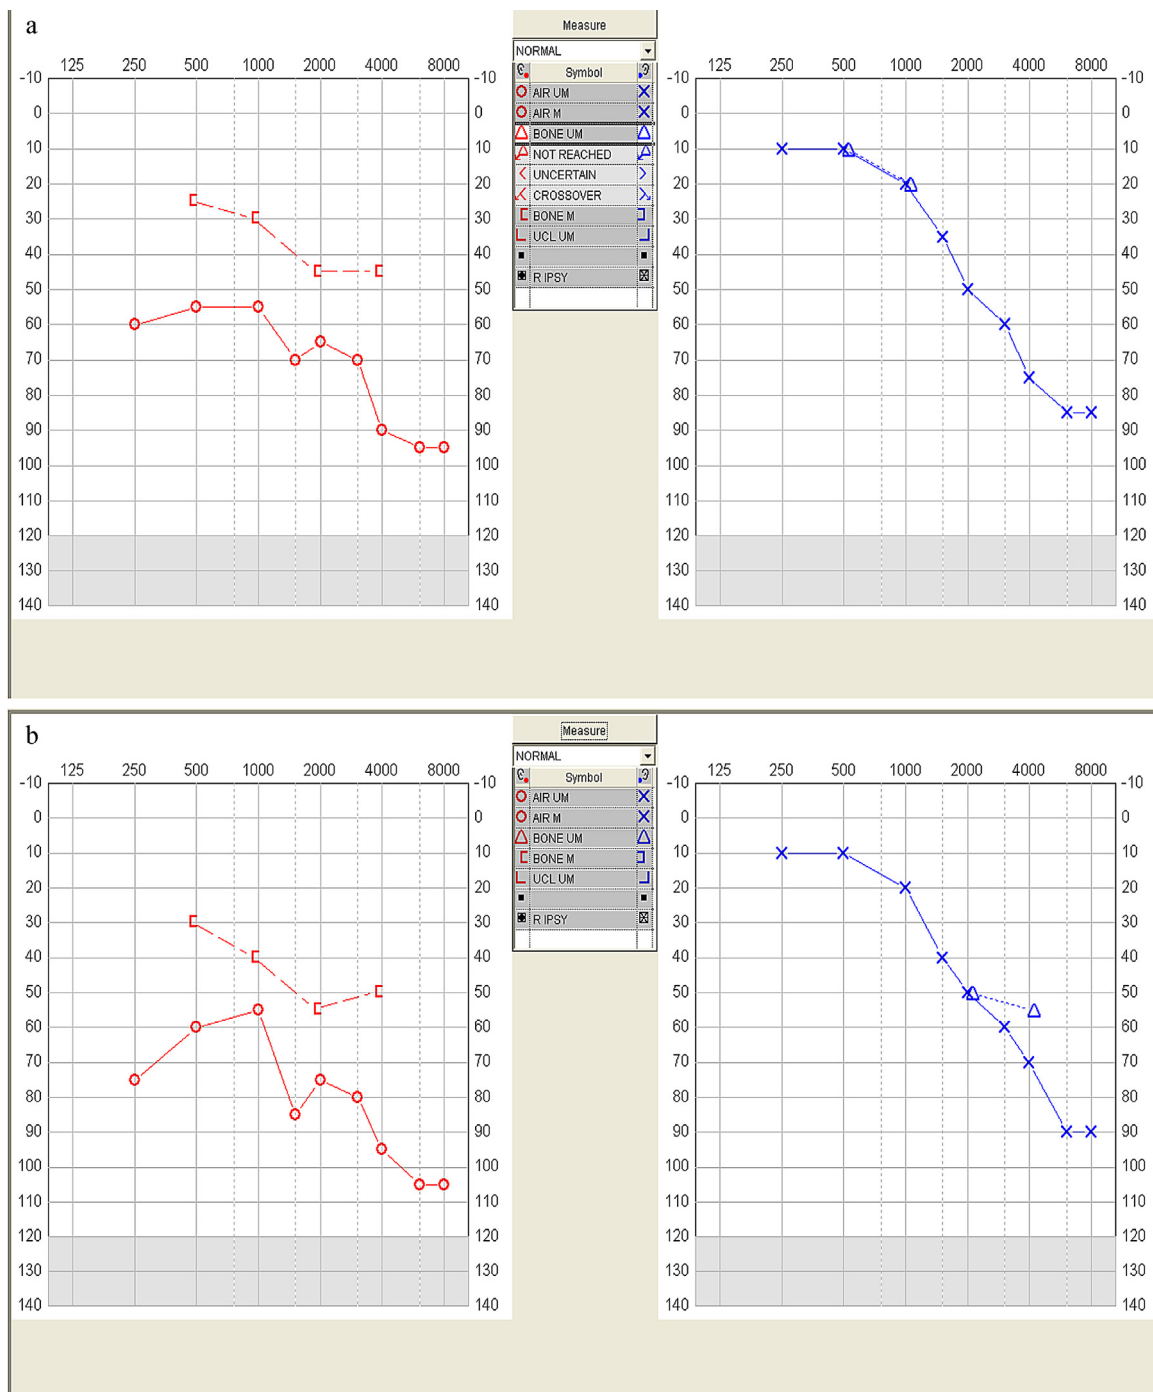
**Fig. 1.** (a) Pre-hearing aid fitting PTA. (b) Post removal of impression material PTA.

A 70-year-old man originally underwent a right myringoplasty for a perforation of the right tympanic membrane (post otitis media) 40 years previously. The operation had been successful and the patient had an intact grafted tympanic membrane on that side. His pure tone audiometry (PTA) at this stage revealed air conduction thresholds of 55–95 decibels Hearing Level (dB HL) with an air-bone gap of 20–45 dB HL in the right ear (Fig. 1a).

Two months later the right central tympanic membrane perforation persisted. However, this was dry and the edges of the perforation appeared healthy. The patient's pain had completely resolved but PTA did reveal a worsening of his hearing on the right (Fig. 1b). The patient is currently deciding whether or not he would like a further myringoplasty on the right ear to seal this new perforation.
