#### Ecological Engineering 59 (2013) 144-156

# Delta dynamics: Effects of a major earthquake, tides, and river flows on Ciénega de Santa Clara and the Colorado River Delta, Mexico

Keywords: Colorado River Delta Channel change Tidal inundation Earthquake surface deformation

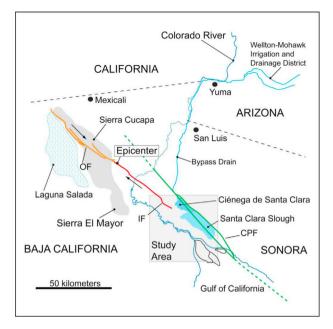
**Fig. 1.** Main features of the Colorado River Delta in Mexico showing the Ciénega de Santa Clara, Santa Clara Slough, Cerro Prieto transverse fault (CPF), the newly discovered Indiviso Fault zone (IF) and other transverse faults (OF) that ruptured during the April 2010 M<sub>w</sub> 7.2 El Mayor-Cucapah Earthquake. The epicenter was 45 km northwest of the study area.

The Ciénega de Santa Clara, a 6000 ha wetland supported by agricultural drain water from Arizona and Mexico, is located 50 km south of the Arizona-Sonora border and 20 km north of the Gulf (Fig. 1). The wetland is situated at the northern edge of the intertidal zone in low ground along the Cerro Prieto transform fault, which marks the eastern margin of the Delta plain and has been considered the principal plate boundary fault in this area (Hauksson et al., 2010).
