Geotechnical characterization of limestones employed for the reconstruction of a UNESCO world heritage Baroque monument in southeastern Sicily (Italy)

A detailed laboratory characterization of limestones employed for the reconstruction of Saint Nicholas Cathedral, a UNESCO World Heritage monument in southeastern Sicily, is presented herein with the purpose of achieving a complete knowledge on the behavior of such rocks under stress, whose engineering geological aspect had not been investigated before for scientific purposes. Specimens were sampled at three sites, where this rock is quarried from two lithofacies of the same geological formation, and are similar to other limestone varieties quarried worldwide and employed as construction material. Although slight differences between the samples occur at a macroscopic scale, geotechnical tests highlighted relevant differences from the physical and mechanical points of view. In order to look for one or more factors responsible of such dissimilarities, a statistical analysis was carried out and interesting outcomes were achieved with the help of a microscopic analysis of the specimens. Moreover, attention was paid on the modes of failu

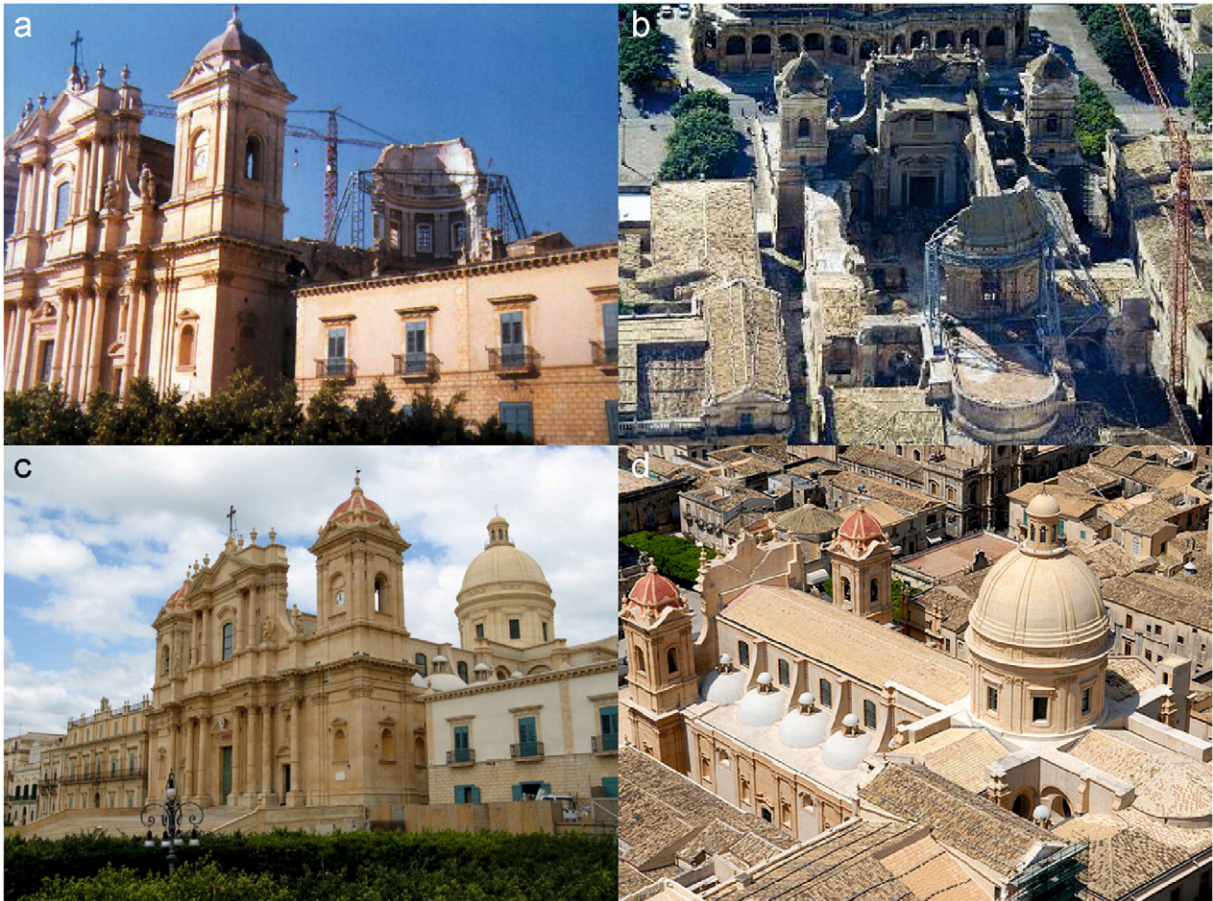
Fig. 1. a) Noto Cathedral after the 1996 collapse; b) aerial view on the collapsed edifice; c) Noto Cathedral after the latest reconstruction works; d) aerial view on the re-built edifice. The photos were retrieved from the web: a) <http://www.raffaeledavinci.it/>; c) <http://rete.comuni-italiani.it/>; b–d) <http://www.lct-architettura.it/> accessed 2 March 2016.

Saint Nicholas Cathedral is one of the most important worship place of Sicily, located in the baroque town of Noto, southeastern sector of the island. Its construction dates back to 1694, one year after a historical earthquake, which razed most of the villages of the area (Bianca et al., 1999; Visini et al., 2009). Its history has been strongly marked by the numerous seismic events occurred over the centuries. In 1727, an earthquake with epicentral area at Noto (Azzaro and Barbano, 2000) caused the failure of some essential structural component of the edifice, leading to the demolition and reconstruction of the whole church. The reconstruction lasted 11 years, but the cathedral did not resist the following 1780 and 1848 seismic shakings, which caused the collapse of the dome and apse in both occasions. In 1862, the re-built structure was opened to the public access, but on 13 December 1990, a 5.3 M earthquake brought severe structural damages and, 6 years later, one of the main pillar of the dome collapsed. This event triggered the failure of the dome itself and, in a domino effect, the collapse of the right aisle and nave (Fig. 1a–b). The damages that after the collapse appeared to be the most significant were a series of vertical cracks on the pilasters, which sustained most of the load of the heavy roof and dome (Tringali et al., 2003). Moreover, such pilasters were found to be the weakest part of the entire building, because of one mistake made during the previous reconstruction: the use of round river stones in their structure.
