An interfacial adhesive analysis of repairing composite patches by electrochemical impedance spectroscopy

B. Díaz*, X.R. Nóvoa, C. Pérez, A. Pintos

ENCOMAT group, EEI, Campus Universitario Lagoas-Marcosende, 36310, Vigo, Spain

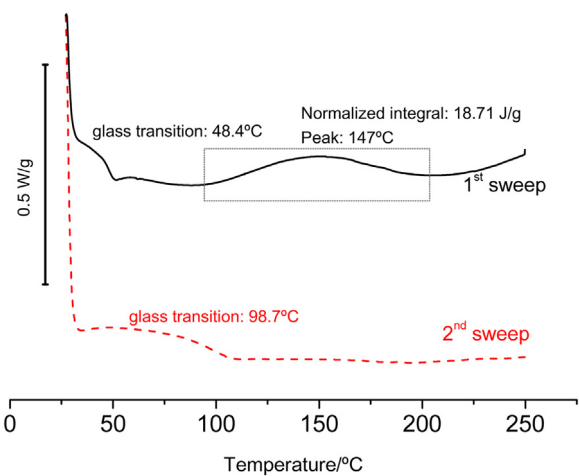
A thermal study by Differential Scanning Calorimetry (DSC) was performed to analyse the adhesive characteristics, the specific experimental details are described in the following section. Fig. 1 depicts the comparison of the first and the second heating scan from 20 °C up to 250 °C. The solid line, corresponding to the first heating scan, clarifies that the followed curing conditions were not

Fig. 1. DSC curves of the adhesive used to join the top composite patch to the marine hull steel, the 1st (solid line) and 2nd (dashed line) heating runs are shown.
