Seismic assessment of existing tall buildings: A case study of a 35-story steel building with pre-Northridge connection

The Tall Buildings Initiative (TBI) program of Pacific Earthquake Engineering Research Center has been expanded to consider the seismic performance of existing tall buildings. This paper selects a 35-story steel moment resisting frame (SMRF), designed in 1968 with construction details representative of that period, for detailed seismic evaluation in the framework of Performance Based Earthquake Engineering (PBEE). A three-dimensional numerical model capturing the mechanical properties of the most critical structural elements was generated using the program: Open System for Earthquake Engineering Simulation (OpenSees). Systematic nonlinear response history analysis (NRHA) under two basic safety earthquake (BSE) hazard levels for existing buildings were performed following ASCE 41-13 guideline. Probabilistic checks on the confidence levels of the building to achieve collapse prevention (CP) and immediate occupancy (IO) at different hazard levels were conducted based on FEMA 351. In addition, damage and loss analysis was carried out using FEMA P-58 PBEE methodology.

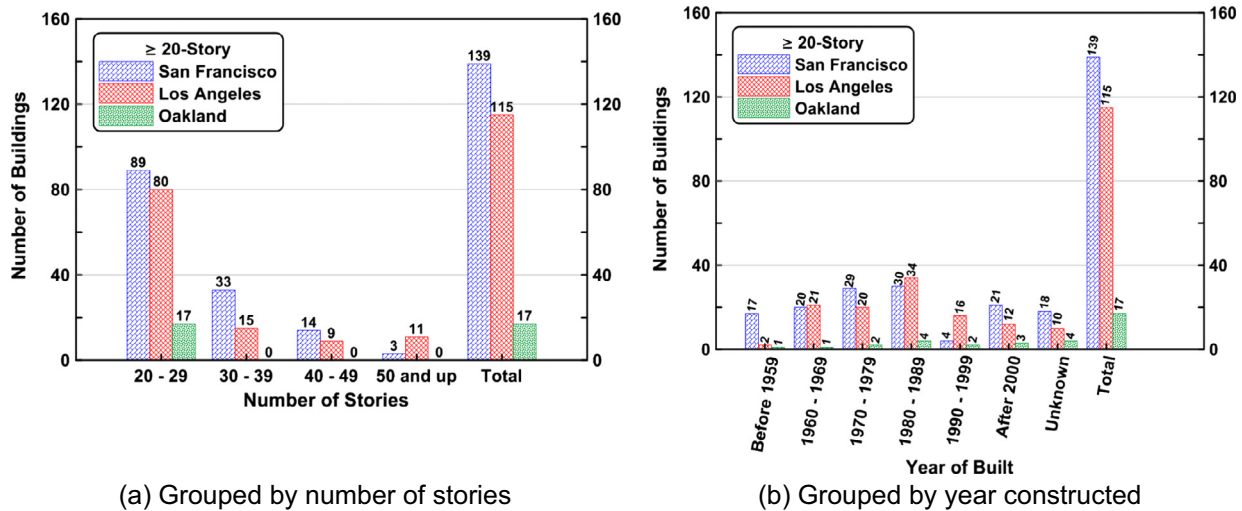
Fig. 1. Inventory of tall buildings located at three major cities in California (San Francisco, Los Angeles, and Oakland).

However, many buildings taller than 20 stories were constructed in the west coast of U.S. between 1960s and 1990s (Fig. 1), when understanding of earthquake hazards and structural behaviors were not as advanced as now. Many of these buildings used welded steel moment resisting frames (SMRF) as lateral
