Comprehensive investigation on the cause of a critical crack found in a diagonal member of a steel truss bridge

Ikitsuki Bridge is a three span continuous truss bridge with a length of 800 m, which was completed in July 1991. In December 2009, a crack which seriously damages the safety of the bridge was found in a diagonal member near an intermediate pier during an inspection for determining points to be annually inspected. In order to identify its cause, some tests on the material used for the cracked member were conducted, and a long-term monitoring of wind and vibration of some diagonal members with similar structural characteristics to the cracked member had been carried out since December 2011. In this article, the outline of the crack is presented and the main causes of the crack are discussed based on the results of the tests and monitoring. The conclusions can be summarized as follows: (i) The crack initiated and propagated to become approximately 200 mm long as a fatigue crack. The quality of material and weld satisfies the requirement for them. (ii) The vibration of the diagonal members is induced by the wind with the velocity of 6–8 m/s and higher than 15 m/s in the dir

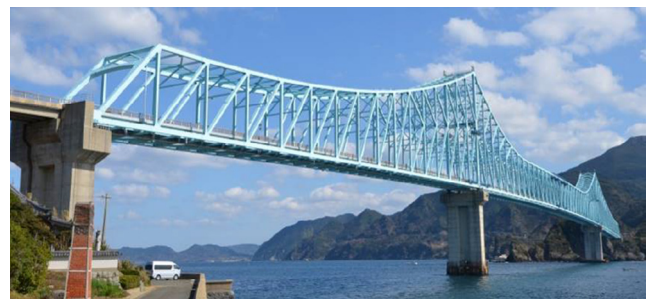
Fig. 2. Photo of the bridge.

The bridge in which the crack was found is a three span continuous truss bridge, Ikitsuki Bridge with the main span length of 400 m, and the span arrangement is 200 m + 400 m + 200 m. It locates in the Hirado city, northwest of Nagasaki Prefecture, and connects Ikitsuki Island and Hirado Island, as shown in Fig. 1. It was completed in July 1991. The completion of this bridge set a new world record for the main span length of this type. The photo of the bridge is shown in Fig. 2.
