High-cycle fatigue performance of high-mast illumination pole bases with pre-existing cracks

Yihui Zhou ^{a,*}, Mina Dawood ^a, Bora Gencturk ^b

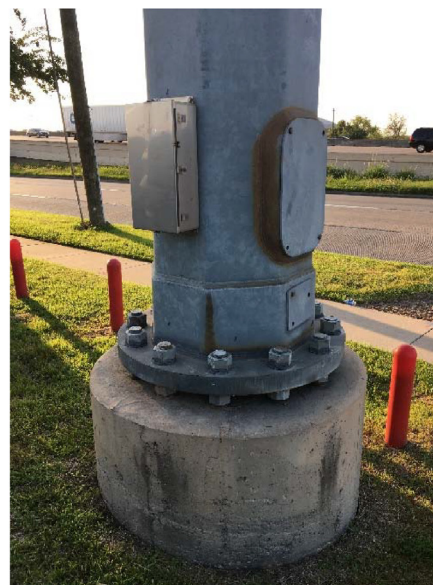
(b) HMIP base connection details

Fig. 1. Typical HMIPs in Texas.

on the failure mechanism of welded joints during galvanizing [6] concluded that the potential for liquid metal assisted cracking (LMAC) is influenced by the stiffness of the joint, presence of residual stresses, zinc bath composition, and dipping speed. Cracks have been identified in many 12-sided galvanized poles although there have not been any reported failures of TxDOT poles. However, as mentioned above, HMIP failures have been observed in other states and reported to be attributed fully or in part to the presence of these cracks [1]. Fig. 1 below shows the typical HMIPs and their base connection details in the state of Texas.
