Wear behaviors of HVOF sprayed WC-12Co coatings by laser remelting under lubricated condition

Kong Dejun^{a,b,*}, Sheng Tianyuan^a^a College of Mechanical Engineering, Changzhou University, Changzhou 213164, China^b Jiangsu Key Laboratory of Materials Surface Science and Technology, Changzhou University, Changzhou 213164, China

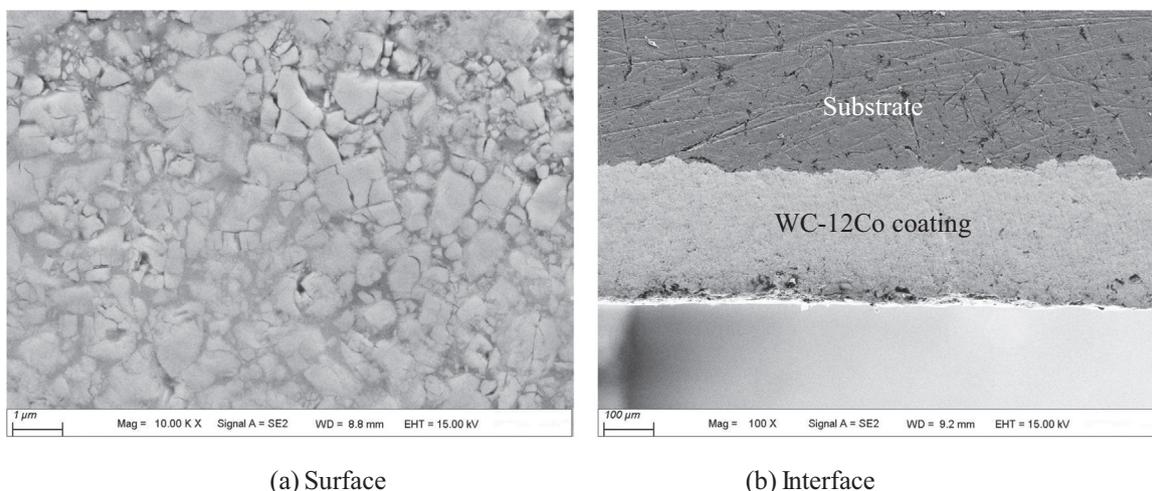
Fig. 1. Morphologies of HVOF sprayed WC-12Co coating surface-interface.

Fig. 1(a) shows the morphology of HVOF sprayed WC-12Co coating. The microstructure of WC-12Co coating was compact and the porosity was low. The porosity of the coating was influenced by the coating processing, the properties of the powder, and the cooling conditions, the coating with low porosity was the main technical advantage of HVOF spraying. During the HVOF spraying, the WC particle with high melting point (2867 °C) was uniformly distributed, the binder of Co with low melting point was melted and filled between the WC particles. The WC hard phase particles with clear edges and corners were clearly visible and the coating microhardness was 1100–1220 HV_{0.3} measured with a microhardness tester. The HVOF spraying time of the WC-12Co powders through the flame was short, only the binder of Co was melted, the ceramic phase of WC particles almost maintained in solid, presenting a semi molten state, and a handful of WC hard phase was spalled after cooling due to lacking of the Co binder. The cracks were caused by the solidification of Co in the process of cooling and solidification. The volume of Co decreased rapidly, the extrusion of WC solid was produced. After sandblast pretreatment, the substrate surface was uneven, prompting the substrate and sprayed coating formed a good “hooked to bite”, which helped to improve bonding strength of the coating and the substrate. Fig. 1(b) shows the interface morphology of WC-12Co coating with the thickness of about 200 μm, and the WC hard phase existed in the coating with a lamellar structure. The particles were finally presented
