### **Engineering Failure Analysis**

# Failure analysis on speed reducer shaft of sluice gate in nuclear power plant

Keywords: Speed reducer shaft Brittle fracture Nuclear power plant Failure analysis

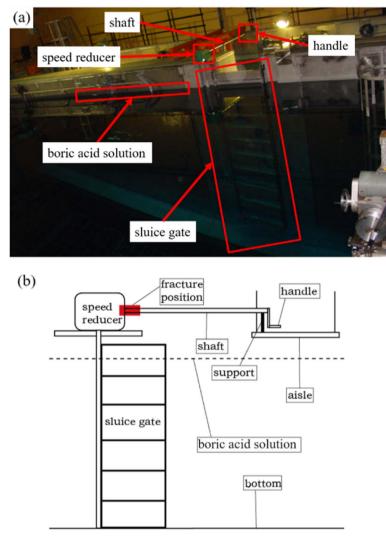
Fig. 1. Appearance and structure of irradiated fuel pool: (a) overall structure and (b) schematic diagram.

It is known that irradiated fuels of nuclear power plant are generally preserved and cooled in specific water pools containing boric acid solution because of residual radioactivity and radiated heat. For the isolation between the irradiated fuel pools as well as the control of the amount of boric acid solution under different circumstances, the sluice gate in a nuclear power plant with 650 MW capacity in southern part of China is driven by speed reducer, which is installed at 20-m-high platform from the bottom of water pool, as shown in Fig.1. Fig. 1(a) shows the external appearance of the sluice gate, and Fig. 1(b) illustrates schematic diagram of the structural components in the irradiated fuel pool. The sluice gate, which is manually driven through output end of speed reducer, is open on-off 10 times per year. The input end of the speed reducer is connected with 2.5-m-long shaft with a manual handle and its more detailed parameters are listed in Table 1.
