# Microstructural investigation of glass fiber reinforced polymer bars

Omid Gooranorimi <sup>a,\*</sup>, Wimal Suaris <sup>a</sup>, Edward Dauer <sup>b</sup>, Antonio Nanni <sup>a</sup>

<sup>a</sup> Department of Civil, Architectural and Environmental Engineering, University of Miami, Coral Gables, 33146, FL, United States

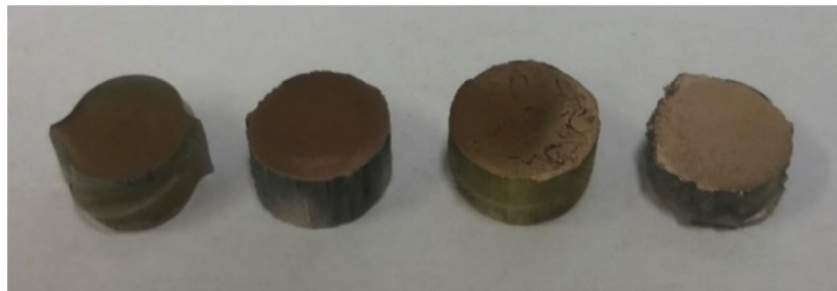
**Fig. 1.** Representative prepared samples (from left: GFRP-A, B, C, and D).

constituents including different surface characteristics have a profound effect on the result of the products. The selected GFRP bars were: Ribbed deformed surface (GFRP-A), fine sand coated with helically wrapped fibers (GFRP-B), double twisted fiber wrapped (GFRP-C) and coarse sand coated (GFRP-D). Table 1 provides the nominal and measured cross-sectional areas for all GFRP bar types. The nominal area is based on a circle with a nominal diameter of 12.7 mm (0.5 in.). The average measured area was computed based on a work by Claire and coworkers [5] following a standard test method for density and specific gravity (relative
