# Puncture position on wind turbine blades and arc path evolution under lightning strikes

Wind turbine blades are easy to get lightning strikes, which is calling more and more attention in recent years. Impulse voltage was applied on different blade structures and materials to study the puncture position distribution and the arc path inside the blade chamber. The experimental results reflected that most puncture points were located in the sandwich structure and thinner glass fiber cover. There was no obvious connection between puncture position, voltage polarities, and voltage peak values as to the experiment in this paper. However, the surface moisture and the experimental electrode position had significant influence for the puncture position. Arc paths inside the blade chamber considering different puncture positions were also studied. It can be concluded from the experiments that the arc usually consisted of surface-arc part and the air-arc part, in which the length of each part varied with the puncture position, voltage peak values and polarities. The research findings revealed the weak areas on typical blade and as well as the possible arc paths inside the sealed chamber, whi

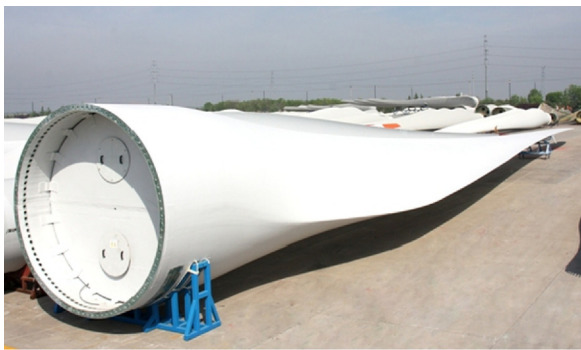
Fig. 2. Blade structure.

a) Real blade

b) Cross-section of blade
