## Evidence of surface accumulation of fillers during the photo-oxidation of flame retardant ATH filled EVA used for cable applications

J-F. Larché<sup>a,\*</sup>, G. Gallot<sup>a</sup>, L. Boudiaf-Lomri<sup>a</sup>, C. Poulard<sup>a</sup>, I. Duemmler<sup>b</sup>, M. Meyer<sup>b</sup><sup>a</sup> Nexans Research Center, 29 rue du Pré Gaudry, 69353 Lyon Cedex 07, France<sup>b</sup> Nexans Research Center, Sieboldstraße 10, 90411 Nürnberg, Germany

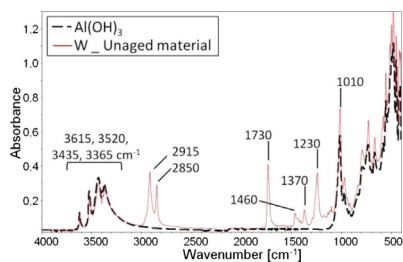
**Fig. 1.** Left: Infrared spectra at initial time in the domain 4000–400 cm<sup>-1</sup> of the studied sample (continuous) and of the pure ATH (dash). Right: Assignments of the main IR features for the initial material.

An industrial Halogen Free Fire Retardant (HFFR) compound used for cable sheathing application has been used in this study. The polymer matrix was a crosslinked Ethylene-Vinyl Acetate copolymer filled with Al(OH)<sub>3</sub> and clays (Kaolin). Residual weight value after a heating ramp up to 800 °C monitored by TGA was ca. 40% which corresponds to a total filler weight percentage close to a total of 55% of which kaolin is approximately 5%. Vinyl Acetate (VA) content was estimated both from FTIR analysis [18] and from the measurement of the melting temperature using DSC [19]. The VA content was found close to 40% in weight in the unfilled matrix.
