Corrosion Science

Effect of irradiation on corrosion of 304 nuclear grade stainless steel in simulated PWR primary water

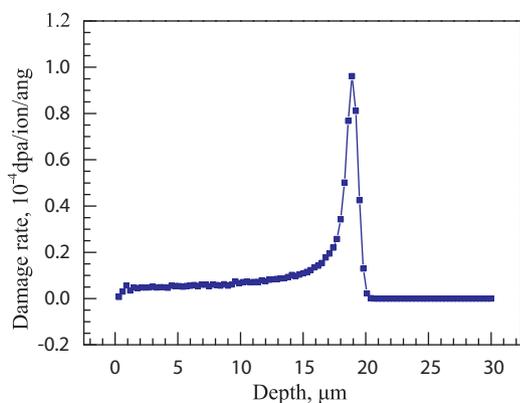
Fig. 1. Damage rate depth profile for 304NG SS irradiated with 2.0 MeV protons as calculated by SRIM 2008 computer code [20].

The material used was solution annealed (SA) 304NG SS with a chemical composition listed in Table 1. Bar-type specimens with a dimension of 20 mm × 3 mm × 2 mm cut from the alloy were wet ground using SiC papers up to 3000 grit, and then polished by diamond pastes of 1.5- and 0.5- μm to obtain a mirror-like surface. After wet-polishing, the specimens were polished by 40-nm colloidal silica slurry for over 2 h to ensure the removal of residual strain prior to proton irradiation. Irradiations were conducted using the General Ionex Tandemron accelerator at the Ion Beam Laboratory of the University of Michigan. The specimens were irradiated with 2 MeV protons at 360 °C at a rate of approximately 6×10^{-6} displacement per atom (dpa) per second (dpa/s) to a dose of 0.5-, 1.5-, 3- and 5-dpa, respectively. The depth damage profile as calculated by the Stopping and Range of Ions in Materials 2008 (SRIM 2008) computer code is shown in Fig. 1 [20]. The damage profile is nearly uniform within the ~ 1 to $\sim 10 \mu\text{m}$ of the whole 20 μm -thick damaged layer, and shows an implantation peak at $\sim 18 \mu\text{m}$. Details about the proton irradiation process are available elsewhere [12,21].
