ESIS TC24 Workshop "Integrity of Railway Structures", 24-25 October 2016, Leoben, Austria

Investigations to introduce the probability of detection method for ultrasonic inspection of hollow axles at Deutsche Bahn

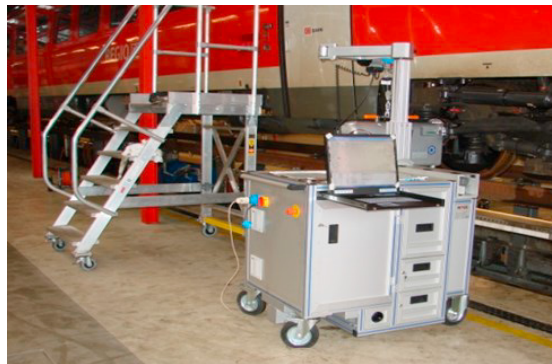
One of the ultrasonic inspection systems for the inspection of hollow railway axles used by Deutsche Bahn is shown in Fig. 1. The system is docked to the side of the axle and the probe module is pushed into the borehole. The axles are inspected from the bore surface.

Fig. 1. Example for a mechanized ultrasonic inspection system for the inspection of hollow axles used by Deutsche Bahn
