Materials Characterization

Microstructure and mechanical properties of surface and subsurface layers in broached and shot-peened Inconel-718 gas turbine disc fir-trees

Metallurgical and mechanical characterization of surface and subsurface regions in broached and shot-peened fir-trees in an industrial gas turbine disc made of Inconel-718 were carried out. High resolution scanning electron microscopy (SEM) equipped with energy-dispersive X-ray spectrometry (EDS), electron backscatter diffraction (EBSD), X-ray diffraction, optical microscopy, and microhardness instruments were employed for qualitative and quantitative assessment of alterations at surface and subsurface levels. Five specific locations along the broached and shot-peened path were selected and thoroughly examined. Original metallography methods were developed to clearly and reliably reveal microstructure constituents. Special emphasis was placed on the generated defects in view of the manufacturer's quality indices, formation mechanisms of defects, and their potential impact on the service capability of the disc. Also, advanced analysis of the EBSD data allowed assessment of the deformed layer thickness as well as the

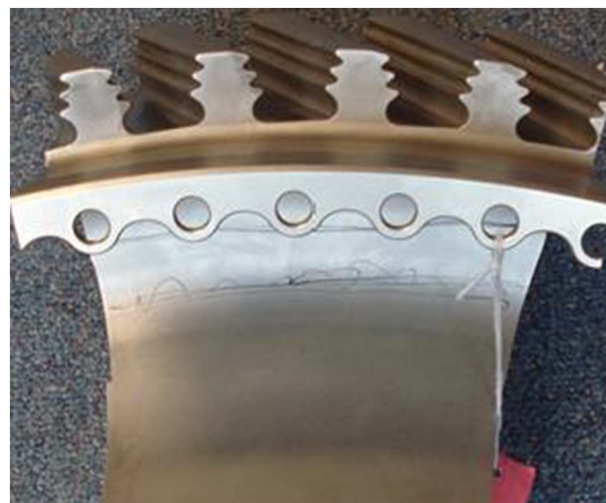
Fig. 1. An as-received section of the Inconel-718 disc with broached and shot-peened fir-trees.

An as-received section of the broached and shot-peened stage 4 Inconel-718 low pressure gas turbine disc was used for this study (Fig. 1). The part was supplied by Siemens Canada Limited, the manufacturer of the gas turbines. The broaching tools were made of HSS and were dressed after broaching of every three discs. Therefore, it can be indicated that sharp broach tools were used in this study. During broaching the disc was submerged in an oil-based coolant (Microcool 153). The broaching and shot-peening process parameters are provided in Tables 1 and 2, respectively. The as-broached disc was not available to perform an independent study on the sole impact of the broaching process on the surface and subsurface alterations.
