## Surface &amp; Coatings Technology

## Novel insight to aluminum compounds in the outermost layers of hot dip galvanized steel and how they affect the reactivity of the zinc surface

Hot dip galvanized zinc coatings (containing about 0.2% of aluminum) were studied with surface analytical techniques. A few nanometer thick aluminum oxide ( $\text{Al}_2\text{O}_3$ ) layer dominated the very outermost surface of such zinc coatings. The inert  $\text{Al}_2\text{O}_3$  layer formed a continuous impermeable barrier on zinc, providing short term humidity resistance. However, this barrier effect was largely lost during temper rolling. Residues of  $\text{Al}_2\text{O}_3$  were shown to prevent titanium hexafluoride pretreatment chemical from reacting with the zinc surface. Segregated aluminum/iron (Al/Fe) intermetallic compounds were also detected at the surface of the zinc coating. The Al/Fe compounds populated the surface immediately beneath the  $\text{Al}_2\text{O}_3$  layer. The Al/Fe precipitates were found predominantly in the dendritic valleys. Repulsion between the Al/Fe precipitates and the pretreatment chemical was observed.

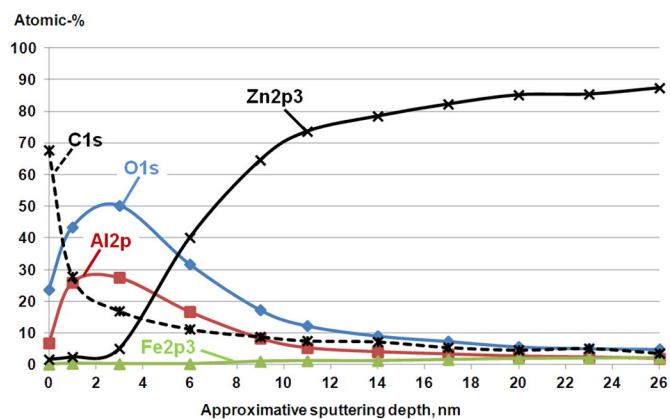
Fig. 1. XPS depth profiles of the prominent elements in the outermost surface layers of nontemper rolled hot dip galvanized steel.

XPS depth profiles of the detected elements on a nontemper rolled HDG sample surface are illustrated in Fig. 1, and the measurement data is shown in Table 1. The high carbon content on the sample surface originates from adsorbed hydrocarbons on the surface, indicated by the rapid decrease of carbon intensity. The outermost surface of the sample was mostly composed of aluminum oxide with only traces of zinc (Table 1). Aluminum oxide zones of about 30–100 Å thickness have been reported to appear on the surface of hot dip galvanized steel [1,12,13,22,27]. Furthermore, the thickness of the surface  $Al_2O_3$  film has been suggested to be independent on the Al concentration in the galvanizing bath and the coating thickness [12,28].

The aluminum was present in its oxide form, which is in accordance with earlier findings [29]. Oxidized zinc was also detected on the surface (Table 1). However, the amount of metallic zinc increased rapidly with decreasing aluminum oxide. Similar observations have been made in other studies [13,28]. Small but significant amounts of iron were detected immediately beneath the aluminum oxide layer. Some investigators have proposed that sub-micron Al segregations populate the surface under the native oxide film, since they have detected small amounts of Al and O even after the sputtering of a film equivalent to the nominal thickness of the native  $Al_2O_3$  film [28]. However, sputtering can also be attributed to create micro-roughness and to push the elements enriched at the surface deeper into the sample matrix, probably explaining some of the tailing that is seen in the XPS depth profiles (Fig. 1) [7,13]. The tailing could also be due to the unevenness of the sample surface.
