## **Environmental Research**

# An investigation into porch dust lead levels

Keywords: Lead House dust Porch Intervention Exposure

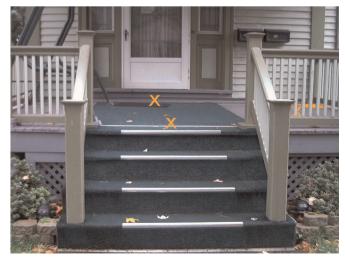
**Fig. 1.** Typical exterior porch in Rochester, New York (X=dust wipe sampling locations; square=location of dust collection plate).

Dust wipe samples were collected from three locations on each porch floor: next to the front entry (entry sample); next to the step or stairs leading to the porch (step sample); and next to a railing away from the entry (railing sample) using the standard HUD method (Fig. 1 – Xs) (HUD, 1995). Dust samples were analyzed for lead using ASTM Method 1644-04 and ASTM Method E1613 or Inductively Coupled Plasma Atomic Emission Spectrometry. Testing laboratories participated in EPA's National Lead Laboratory Accreditation program. Baseline dust wipe samples were also collected by city funded contractors from window sills and nonentryway floors from inside the structure as part of a risk assessment conducted according to the HUD Guidelines for the Evaluation and Control of Lead-Based Paint Hazards in Housing (HUD, 1995).
