Investigation of mobile ultrasonic propagation imager as a tool for composite wind blade quality control

This study proposes an in-process quality control (IPQC) method based on an ultrasonic propagation imaging (UPI) system. The UPI system is based on laser-induced ultrasound and has the capabilities of noncontact, fast, curved structural and real-time inspection results. These capacities have the potential to be applied to IPQC in blade manufacturing and assembly in a Smart Blade Factory. To provide a proof-of-concept for Smart Blade Factory based on the UPI system as an IPQC tool, a 750-kW actual blade section was tested, and the inspection results were presented based on a multiple-defect visualization platform. Debonding, inclusion and void defects in a wind blade made of glass fiber reinforced plastic and PVC grid panels were studied. The inspection results proved high feasibility for the application of the UPI system to IPQC in blade manufacturing.

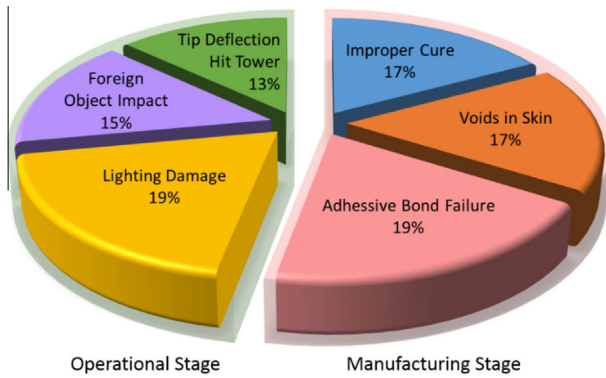
Fig. 1. Blade defect and damage at manufacturing and operational stages [2].

manufacturing stage, a strict in-process quality control (IPQC) technology is highly recommended to detect the key manufacturing defects such as adhesive bond failure (19%), voids in skin (17%) and improper curing (17%) as presented in Fig. 1.

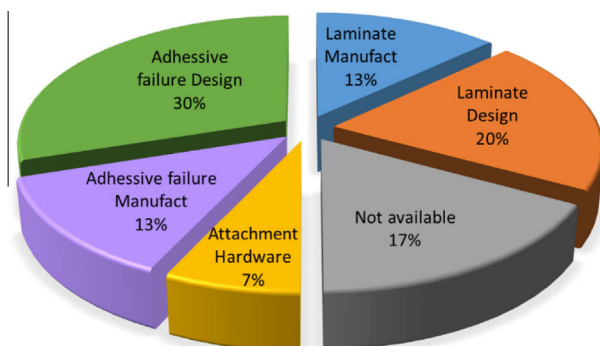
Fig. 2. Composite wind turbine blade failure modes [2].
