Strengthening and rehabilitation of deteriorated timber bridge girders

Research has shown that strengthening of degraded rectangular timber is possible via the use of Fibre Reinforced Polymers (FRP). Tests were conducted at James Cook University (JCU) using three round timber girders removed from a railway bridge in North Queensland, Australia. These were retrofitted with either a Carbon Fibre Reinforced Polymer (CFRP) or Glass Fibre Reinforced Polymer (GFRP) composite in one of three different strengthening profiles. Due to extensive deterioration, two of those girders failed during preliminary tests and thus were repaired as opposed to strengthened. The repaired members sustained enhanced moment capacity and ductility from their initial failure values. The unbroken girder when strengthened, produced a 30% reduction in deflection for the same moment while bending stiffness was increased by 30% from its initial un-strengthened state.

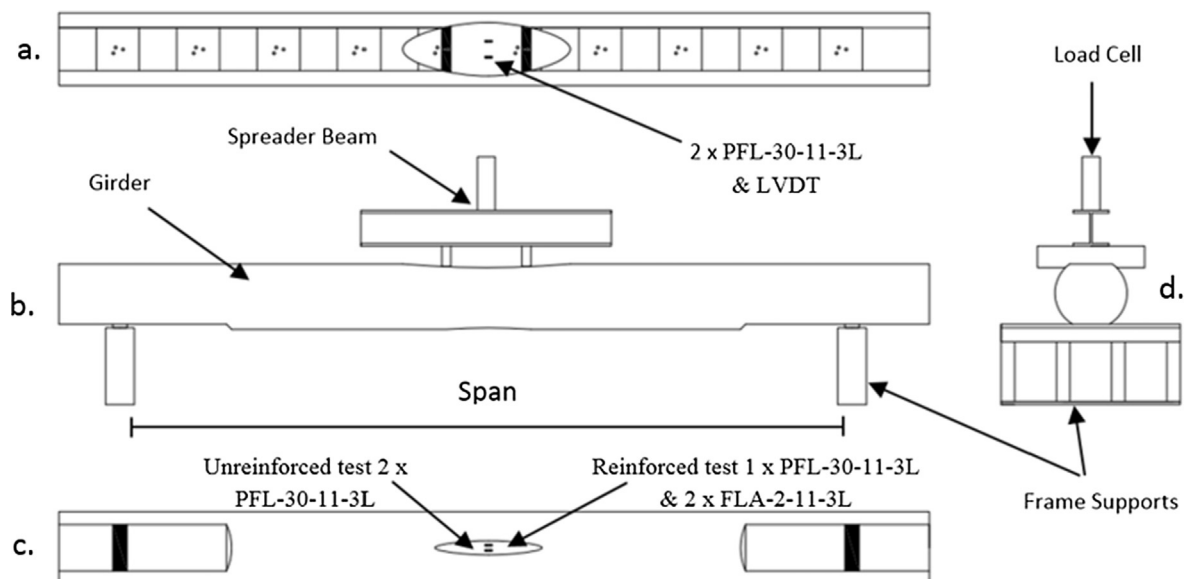
Fig. 1. Schematic view of test setup. (a) top view, (b) side view, (c) bottom view, (d) end view.

All tests were conducted using four-point bending setup (Figs. 1 and 2). The reaction frame had a maximum load capacity of 440 kN with the loads being applied on the girders using an Enerpac hydraulic ram and load cell with capacity of 600 kN. Vertical deflection at mid span was measured using an LVDT. Strains in the timber and FRP were measured using strain gauges (Timber: PFL-30-11-3L and FRP: FLA-2-11-3L) attached at midspan on both the compression and tension faces in the region of pure bending.
