Construction and Building Materials

The inspection of level crossing rails using guided waves

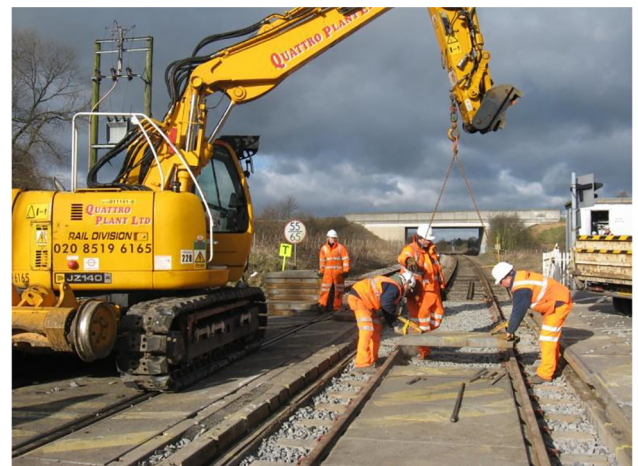
Fig. 3. Lifting the deck to allow visual inspection of the rail.

Once possession of the track is taken heavy machinery is used to remove each deck panel one by one, see Fig. 3. An average team of six men are required and the process of removing the panels which can take more than 2 h to complete. Replacement of the panels is the reverse process and requires a similar amount of time.
