Determining the effective service life of silane treatments in concrete bridge decks

Mehdi Khanzadeh Moradillo*, Bryan Sudbrink, M. Tyler Ley

Department of Civil and Environmental Engineering, Oklahoma State University, Stillwater, OK 74078, USA

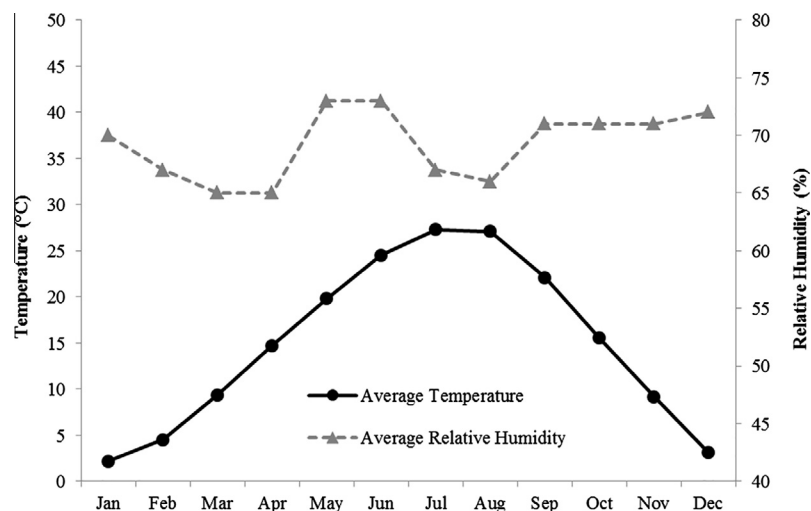
Fig. 1. Variations in mean ambient temperature and relative humidity of Stillwater, Oklahoma [31].

Cores that were approximately 18 mm in diameter by 25 mm in height were taken from the driving lane and shoulder of 60 bridge decks. Six cores were taken from each bridge for a total of 360 cores. Three cores were taken from the shoulder and three from the travel lane. These cores were taken at parallel locations so that the amount surface wear could be compared. Cores were taken from areas that were clear of debris, cracks, oil, and salt scaling damage. These cores were also inspected to be sure that they did not contain a large aggregate near their surface as this would interfere with the measurement of the silane penetration. If this occurred then another core was taken. These cores were collected with a cordless drill without using water to cool the bit. This technique allowed two researchers to sample each bridge in about 1 h. This minimized the requirement for traffic control and allowed more samples to be collected in a day. Since the cores were small, this minimized damage and patching to the bridges. These bridges had an age range of 6–20 years. Details about the sampled bridges can be found in another publication [28]. The investigated bridges had an average annual daily traffic (AADT) between 3,800 and 18,000 [29]. Typical weather conditions in Oklahoma are shown in Fig. 1.
