# Failure investigation on a coastal wind farm damaged by super typhoon: A forensic engineering study

This study presented a failure investigation on a wind farm which is located on the southeast coast of Mainland China and was severely damaged by two super typhoons: i.e., Dujuan in 2003 and Usagi in 2013. Failure characteristics of the wind farm in terms of rotor blade damage, tubular tower collapse and wind turbine (WT) burn were examined from a forensic engineering perspective. A systematic procedure was proposed to quantitatively investigate structural failure by calculating the extreme wind loads and re-constructing structural models for composite blades and steel towers. It was found that both extreme winds and the stop positions of WTs were critical to turbine failure due to the change of wind direction during typhoon impact. The overstrain/overstress was identified as the plausible root cause for structural failure of WTs. In addition, the dramatic reduction of shell wall thickness due to possible design defect was also found to be responsible for the tower collapse in this study.

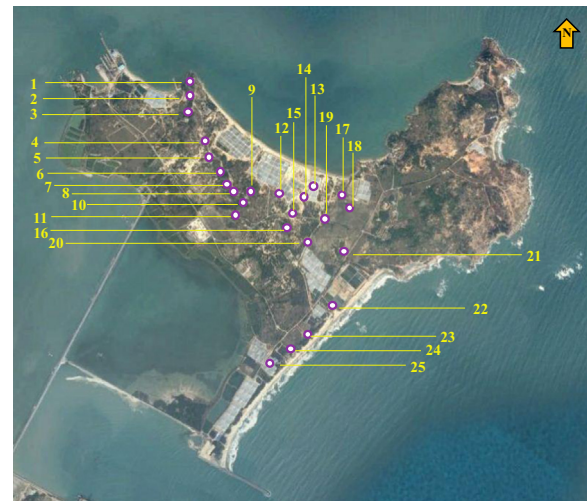
**Fig. 3.** The distribution of wind turbines over the wind farm.

The distribution of 25 wind turbines over the wind farm is shown in Fig. 3. It can be seen that WT#1–11 were located along the ridge at the west side and WT#12–21 were located in the
