Analysis of damage data of low-rise buildings subjected to a shallow M_w 6.3 earthquake

Bjarni Bessason^{a,*}, Jón Örvar Bjarnason^b, Ari Guðmundsson^b, Júlíus Sólnes^a,
Scott Steedman^c

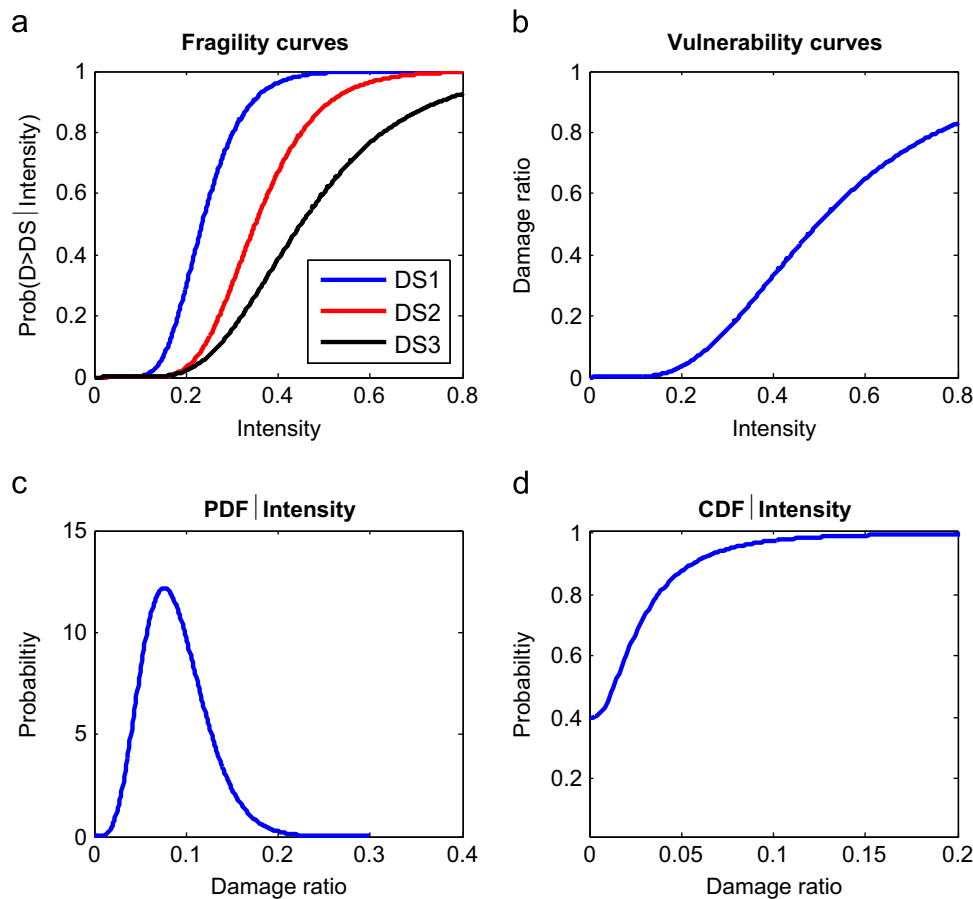
Fig. 1. Schematic presentation of different forms of damage relationships for a given building typology. a) Fragility curves showing probability of exceeding predefined damage states (DS1, DS2 and DS3) for a given intensity, b) Vulnerability curve showing expected damage ratio for a given intensity, c) Probability density function showing damage ratio for a given intensity, d) Cumulative distribution function showing damage ratio for a given intensity.

Seismic vulnerability of different building typologies is described in several ways in the literature. *Fragility curves*, as defined in many references ([1,2]), show the probability of reaching or exceeding a specific damage state as a function of ground-motion intensity (see Fig. 1a). The damage state is defined by a descriptive damage index as none, slight, significant and collapse [3], or in a more detailed manner: none, slight, light, moderate, extensive, partial collapse and collapse [4]. Each state can have a more detailed description. For instance “slight” may be associated with “fine cracks in plaster partitions/infills” [4], and/or may be connected to the damage ratio within a given range, such as 0–5%. The damage ratio is here defined as the ratio of repair cost to replacement cost of a building. *Vulnerability curves* are used in some references [5] to show the damage ratio as a function of ground-motion intensity (see Fig. 1b). It is important to note that the definition of these terms is not universal and in some references are used interchangeably [3,4,6].

Conditional Probability Density Functions (PDF) which show the distribution of the damage ratio for a given building typology and intensity interval are also used in the literature (see Fig. 1c).

PDFs were used, for instance, to describe the vulnerability of California buildings by the Applied Technology Council [7,8]. An alternative to PDFs is to use conditional Cumulative Distribution Functions (CDF), which can take into account the fact that some fraction of building stock will be undamaged after an earthquake, a result that is then reflected by a step at the beginning of the curve (Fig. 1d [9]).

subcategories. These databases have already been used by the authors to derive conditional CDFs for damage ratios (see Fig. 1d) for five types of low-rise buildings that are most common in South Iceland [9].
