Structural failure in large-span timber structures: A comprehensive analysis of 230 cases

Philipp Dietsch*, Stefan Winter

Technical University of Munich, Germany

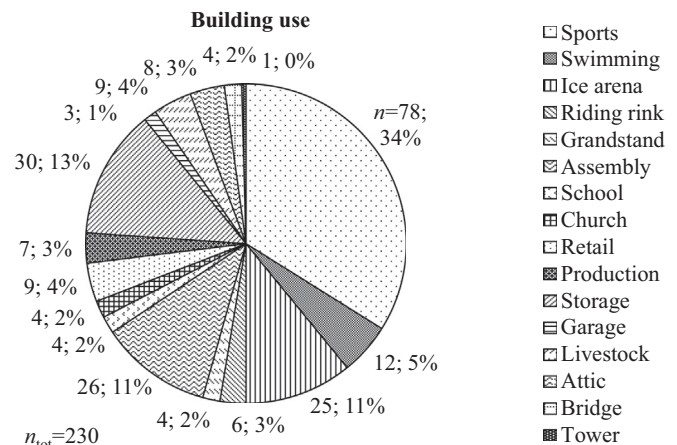
Fig. 1. Distribution of building use (sequence of entries in legend clockwise, starting at the twelve o'clock position).

The majority of buildings was built in the 1970s (24%) and 1980s (31%), the oldest building dates from 1900, the average age at time of data acquisition was 27,5 years. Fig. 1 shows the multitude of uses for large-span timber structures, e.g. sports halls, halls for public assembly or storage facilities. The large proportion of indoor ice rinks is due to the collapse of the roof of the Bad Reichenhall ice arena [3] after which the building authorities ordered an assessments of all timber roof structures of ice rinks in Germany. A comparison with the frequency distribution of all built large-span timber structures and their respective use could not be realized since, despite intensive research, no related data could be found. Closely correlated to the building use are the climatic boundary conditions within respectively around the building. 87% of the structures are within a closed building envelope (62% heated, e.g. gymnasiums; 25% unheated, e.g. storage facilities), 8% are in external climate but covered, e.g. stables/livestock; 5% are directly exposed to weather, e.g. bridges.
