Failures of structures during the October 23, 2011 Tabanlı (Van) and November 9, 2011 Edremit (Van) earthquakes in Turkey

The October 23, 2011 Tabanlı and November 9, 2011 earthquakes that hit Tabanlı and Edremit districts of Van province in Turkey and their impacts on different types of structures are studied in this paper. According to United States Geological Survey (USGS), the magnitudes of these earthquakes, which caused partial or total collapse of numerous buildings and more than 600 casualties, were 7.1 and 5.6, respectively. Other than negatively impacting all aspects of daily life, the earthquakes remarkably disrupted the economical activities in the area. This paper summarizes the seismological characteristics of the affected region, the general characteristics of the strong ground motion and the types of structural damage observed during site investigations. Emphasis is given to the failures and seismic performance of different types of structures, through detailed explanation of damage mechanisms. The structural damage levels are observed to be directly related to the extent of irregularities of the structural system, level of the insufficient quality in the workmansh

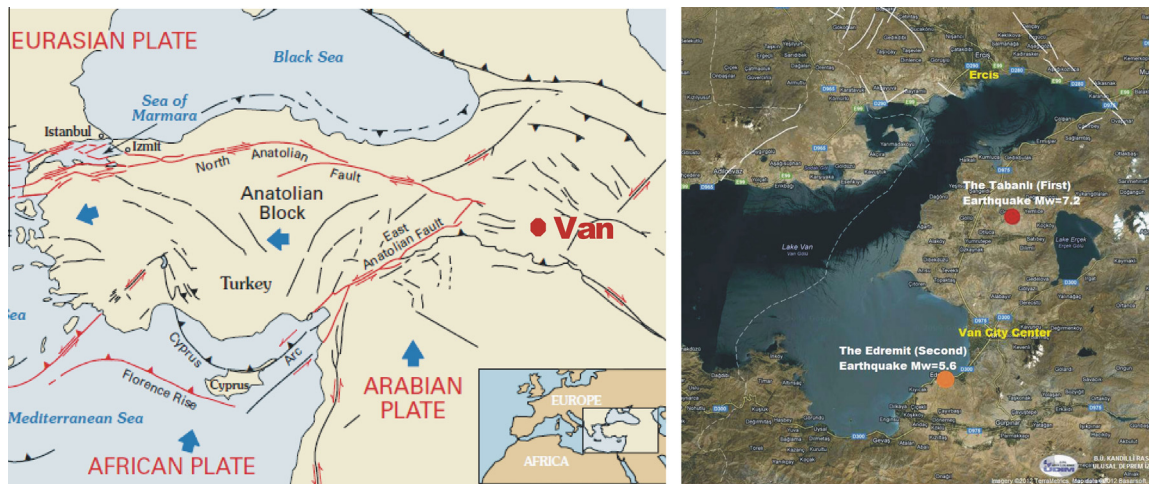
Fig. 1. Seismotectonics of Turkey (modified from [1]) and region affected by the earthquakes [3].
