Investigation into recurring military helicopter landing gear failure

The skid landing gear of a military helicopter failed while the helicopter was moored on the ground at the airport. The rear cross tube of the landing gear assembly was found fractured into two separated pieces. The fracture occurred in the right flange of the rear cross tube, where a connection with the spring tube is established using a clamp. The initial visual inspection of the fracture zone revealed a presence of heavy corrosion and significant damage of the anti-corrosion protective layer on the outer surface of the flange of the rear cross tube. Fractographic analysis highlighted corrosion as the main cause of the failure. Evidence was found to show that the fracture was initiated from corrosion pits located on the exterior, underside of the cylindrical part of the flange. Metallographic examination discovered corrosion pits with micro cracks and multiple branched secondary cracks in the crack origin area, indicating the occurrence of stress corrosion cracking. Chemical analysis of the corrosion deposits showed the presence of sodium, chlorine, calcium and sulfur. The stress analysis of the helicopter lan

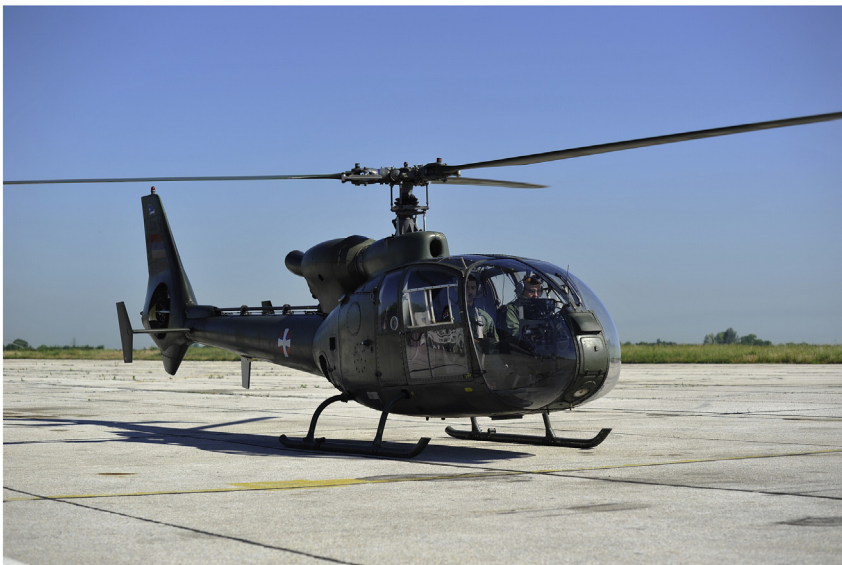
Fig. 1. Military helicopter Aerospatiale Gazelle SA 341H.

This paper highlights the metallurgical and numerical approaches to failure analysis of the skid landing gear of the military multi-role, lightweight, single-engine, helicopter Aerospatiale Gazelle SA 341H, Fig. 1. The helicopter skid landing gear (HSLG) consists of two skid tubes and two cross tubes as is shown in Fig. 2. Skid and cross tubes are connected by four vertical spring
