Damages of wind turbine blade trailing edge: Forms, location, and root causes

The geometrical form and the manufacturing technique make the trailing edge of the wind turbine blade more susceptible to damage. In this study the trailing edge in a number of 81 blades of 100 kW wind turbines and 18 blades of 300 kW wind turbines of working life ranging between 6.5×10^7 and 1.1×10^8 cycles were completely visually scanned. The different damages were classified and allocated in their exact position relative to the blade length. Cracks in different orientations with the blade length were the frequent types of damages which found on the trailing edge. First, longitudinal cracks (LCs) that found along the blade trailing edge from the blade root to the tip were in lengths that varied from a few centimeters up to around 1.35 m. Second, transverse cracks (TCs) were found in either simple TCs which growing on one shell at the trailing edge or round TCs which growing across the two shells. TCs lengths were ranging from 20 to 50 mm. Third, edge damages were detected in the form of edge cuts or crushing. The possible root causes of the different types of cracks have been discussed.

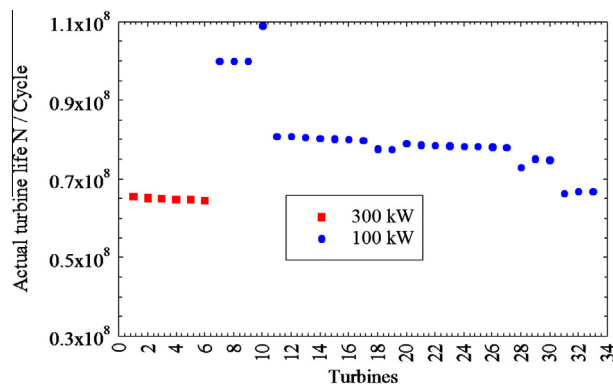
Fig. 1. Actual working lives (in cycles) against the turbine number.

where, RPM is the average number of cycles per minutes of each turbine model, the age is based on the date of start working date after installation of each turbine and the capacity factor describes the net time fraction of working excluding the times when the wind speed is under the cut-in speed. The availability factor of these turbines is ranging between 0.95 and 0.98. The capacity factor is 0.22 and 0.25 and the RPM is 33 and 38 for the 100 kW and 300 kW turbines, respectively. The actual turbines working lives were calculated in number of cycles till the time of inspection and found between 6.5×10^7 and 1.1×10^8 cycles which are illustrated against the different turbines in Fig. 1. The calculated working number of cycles was consistent with published information [3] which confirmed that the working life of 20 years delivered a number of cycles in the order of 10^8 cycles.
