Solar Energy Materials & Solar Cells

Nondestructive characterization of encapsulant discoloration effects in crystalline-silicon PV modules

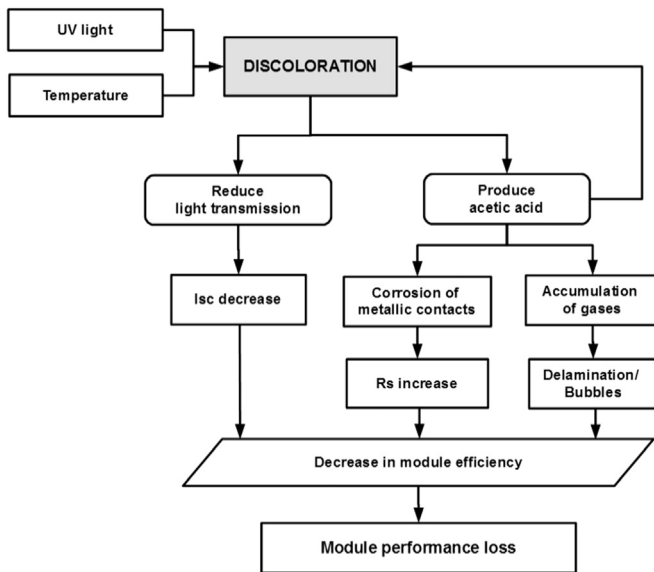
Fig. 1. Causes and effects of encapsulant discoloration in the PV module.

zones [3]. Fig. 1 depicts the causes of discoloration and its adverse effects on the module performance and reliability. Discoloration is caused by the photo-thermal degradation of EVA encapsulant under high UV light exposure and high temperature, which results in the appearance of color over the solar cells [1,4,5]. It primarily decreases light transmission to the solar cells, which directly reduces the short-circuit current (I_{sc}) of the module and decreases the module efficiency. There are some indirect effects of discoloration, which also contribute in efficiency reduction. EVA degradation leads to the production of acetic acid and other volatile gases, which get trapped within the module at different interfaces, causing the delamination or bubbles formation that reduces the performance and reliability [6,7]. The acetic acid attacks the metallic contacts of solar cells and causes corrosion, which increases its series resistance (R_s) and ultimately reduces the power yield [8]. The acetic acid also acts as self-catalyst that enhances the reaction pathways of the polymer degradation. The discoloration is generally non-uniform over the module, resulting in additional power loss due to mismatch within a cell as well as module. All
