4th International Conference on Power and Energy Systems Engineering, CPESE 2017, 25-29
September 2017, Berlin, Germany

Case Analysis on Partial Discharge Signal of XLPE Cable T-Joint by Using High-Frequency Pulse Current Method

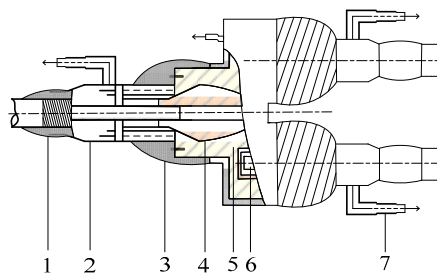
The T-joint is premoulded cold-shrinkable silicone power cable accessories. The design structure is shown in Figure 2.

1 lapped insulation;2 barrier sheath;3 lapped insulation;4 stress-cone;5 the body of branch-joint;6 connector;7 earth conductor

Figure 2 The Structure Diagram of T-joint
