Journal of Iron and Steel Research, International

# Microstructure failure in ferrite-martensite dual phase steel under in-situ tensile test

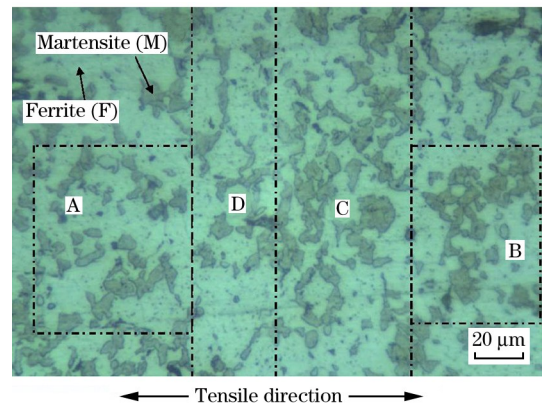
**Fig. 3.** Microstructure observed in the in-situ observation test.

The initiation and propagation of micro-cracks in the observed microstructure (Fig. 3) with martensite frac-

tion of 32.4% were observed and captured. To simplify the analysis, the observed microstructure was divided into four sub-regions named A, B, C and D. Martensite fractions in four sub-regions were about 30.53%, 33.71%, 36.89% and 24.59%, respectively.
