Feasibility of identifying leaking fuel rods using gamma tomography

Scott Holcombe^{a,*}, Staffan Jacobsson Svärd^b, Knut Eitrheim^a, Lars Hallstadius^c, Christofer Willman^c

^a OECD Halden Reactor Project, P.O. Box 173, 1751 Halden, Norway

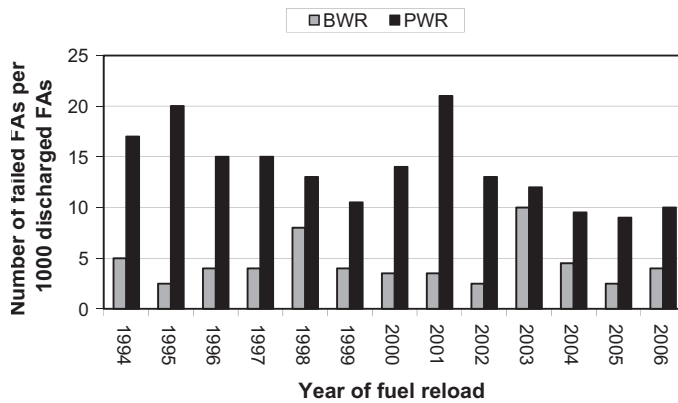
Fig. 1. World average fuel assembly failure rates for BWRs and PWRs during the period 1994–2006, according to (IAEA, 2010). This information is based on 417 LWRs which operated during the given time period and which in total reported nearly 800 failed fuel assemblies.

According to (IAEA, 2010) the world average fuel failure rates for Pressurized Water Reactors (PWRs) and Boiling Water Reactors (BWRs) for the period 1994–2006 were 13.8 respectively 4.4 failed fuel assemblies per 1000 discharged fuel assemblies. The number of leaking fuel assemblies per 1000 discharged assemblies for the period 1994–2006 is shown in Fig. 1. This information is based on 417 Light Water Reactors (LWRs) which in total reported nearly 800 failed fuel assemblies during this time period.
