Case study

# Earthquakes and ancient leaning towers: Geodetic monitoring of the bell tower of San Benedetto Church in Ferrara (Italy)

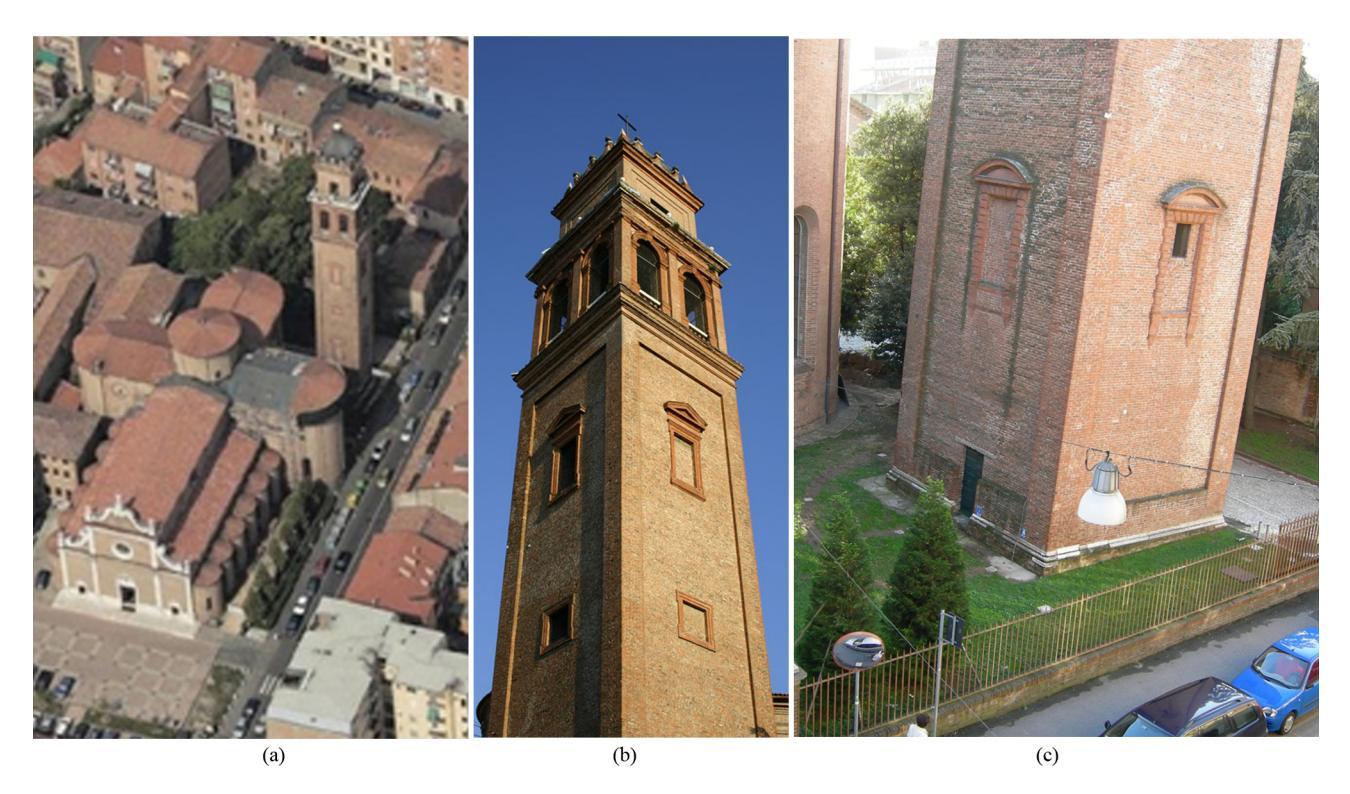
Fig. 1. a: San Benedetto Church in Ferrara (Italy) and the bell tower; b: detail of the upper part of the tower and (c) its base.

The bell tower of San Benedetto Church (Fig. 1) was built between 1621 and 1646; its design is traditionally attributed to

G.B. Aleotti (1546–1636), architect at the court of the Dukes of Este. The masonry tower rises about 55 m.
