Engineering Structures 106 (2016) 53-67

Failure of masonry structures in earthquake: A few simple cost effective techniques as possible solutions

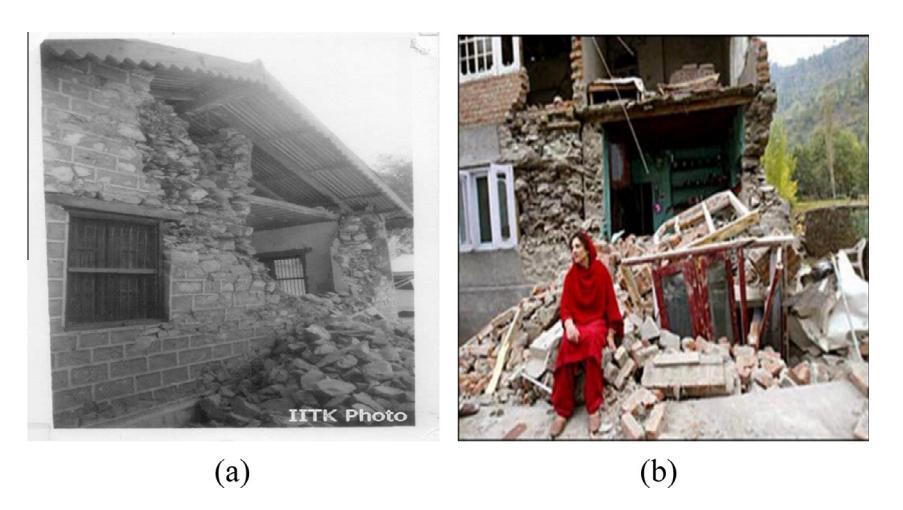
Fig. 1. Collapse/damage of unreinforced masonry buildings: (a) corner/junction failure in Uttarkashi earthquake, 1991 (NICEE, [1]) and (b) out-of-plane wall failure in Pakistan earthquake, 2005 (EERI, [2]).

Horizontal shear failure, corner/junction failure and failure of out-of-plane walls initiated by junction failure are the most common type of failure in unreinforced masonry structures when subjected to seismic excitation. Corner/junction is identified as the weakest portion of such structures. It is needed to improve the integrity of the structures to behave as a single unit and to ensure proper interlocking between orthogonal walls to reduce the causalities during earthquake. Such issue is discussed in details by D'Ayala [34], Murty [35,36], etc. Keeping in view of the above mentioned facts, the present study tried to use PP band, steel wire mesh and reinforcing bars to strengthen URM walls for achieving better seismic performance. Use of PP band and wire mesh help to improve the integrity of the structures. Horizontal reinforcing bars ensure proper interlocking between orthogonal walls.
