Journal of Constructional Steel Research

Modeling parameters for predicting the postbuckling shear strength of steel plate girders

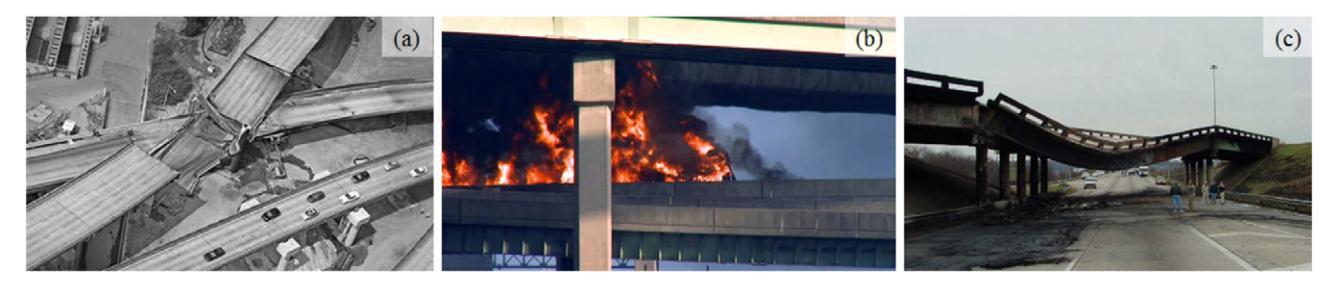
Fig. 1. (a) MacArthur Maze fire in Oakland, CA [1], (b) I-81/Rt 322 interchange fire in Harrisburg, PA [21], and (c) malfunction junction fire in Birmingham, AL (photo courtesy of Alabama Department of Transportation).

Several notable fires have occurred throughout the United States that have caused steel girder bridges to collapse or be severely damaged [1]. The collapse of two spans of the I-80 east to I-580 east flyover within the MacArthur Maze freeway complex in Oakland, California due to a tanker truck fire underscores the severity of these fire scenarios. The aftermath of this collapse that occurred on April 29, 2007 is shown in Fig. 1(a). Replacing the bridge cost \$9 million, while the economic impacts to the San Francisco Bay area were estimated to be \$6 million per day of the bridge closure (26 days total) [1]. Fig. 1(b) shows a tanker fire within the I-81/Route 322 interchange in Harrisburg, Pennsylvania

on May 9, 2013. While the steel bridge did not collapse, extensive damage prompted its demolition. Fig. 1(c) shows extensive deformations in

bridge steel plate girders due to a tanker truck fire at the I-65/I-59/I-20

interchange in Birmingham, Alabama on January 5th, 2002. Similar to

the tanker truck fire shown in Fig. 1(b), the bridge did not collapse

but the damage was extensive and the structure was demolished

and rebuilt. Web shear buckling was observed in the bridges shown in

Fig. 1(b) and (c), which motivated studies to explore how this failure
