Case report

Operative management of a shear fracture of the bilateral capitellum: A case report and review of the literature

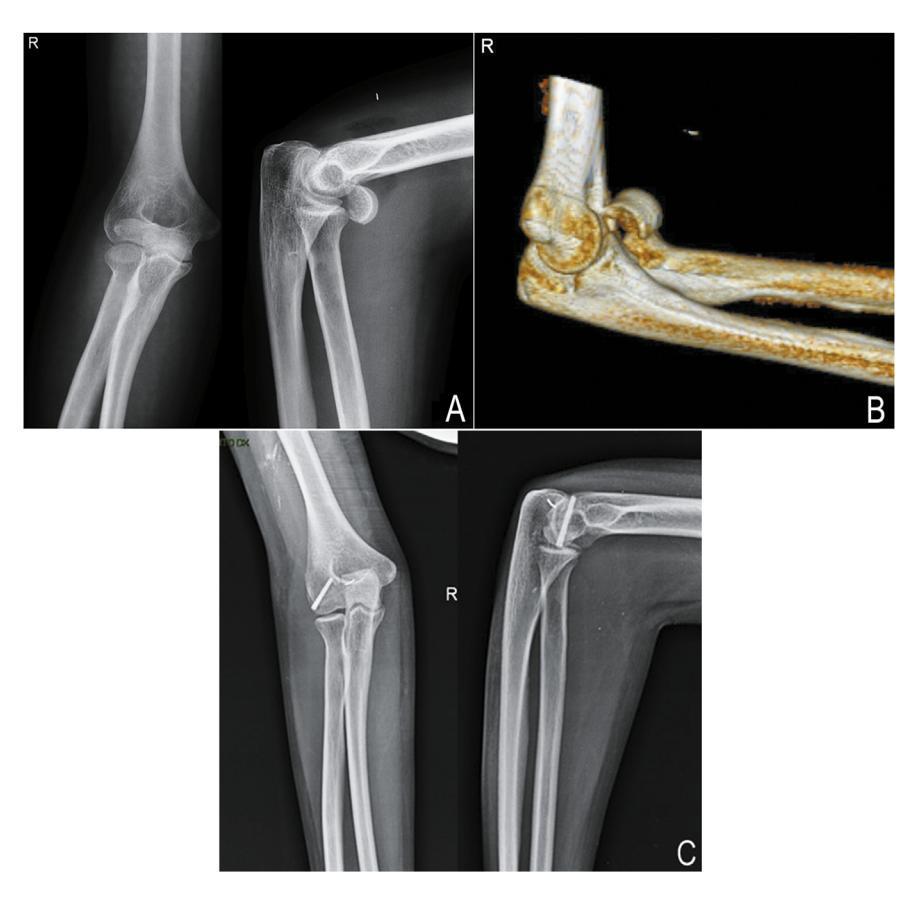
Fig. 1. A: Preoperative X-rays of the right elbow in AP and lateral view. The capitular fracture is easily identified on the lateral projection. B: CT 3D scan reconstruction. C: Postoperative X-rays after headless screw osteosynthesis.

A 38-year-old female fell onto both her outstretched hands after a motorcycle accident. Clinical examination at the emergency department in our hospital found diffuse swelling of both elbows, together with intense pain and impairment of any elbow joint motion. Radiographs in the AP and lateral planes showed a bilateral fracture of the capitellum humeri without evidence of elbow dislocation (Figs. 1a and 2a). Subsequent X-rays to the forearm and wrist did not reveal concomitant fractures or distal radio-ulnar (DRUJ) joints. The next day, a CT scan was performed with a 3D reconstruction (Figs. 1b and 2b) in the sagittal and coronal planes for a detailed preoperative evaluation. Both capitellar fractures were classified as type 1A. Type "1" refers to the Bryan and Morrey's classification, describing a shear fracture in the coronal plane involving most of the capitellum and none of the trochlea. "A" type, according to Dubberley et al, refers to the absence of posterior condylar comminution. At the third day after trauma, our patient underwent bilateral same-day surgery (ORIF), simultaneously for both capitellar fractures, by two surgical equips.

Debridement of the free capitellar fragment was performed, removing any residual fibrous tissue and hematoma. The fragments were reduced in direct visualization, held with a dental pick and then temporally fixed with the guide wires of the mini Acutrac (Acumed, Hillsboro, OR, USA) headless screws. Definitive osteosynthesis from anterior to posterior, with one headless Acutrac mini compression screw was realized at both sites, achieving a stable and anatomical reconstruction of the articular surface with screws buried underneath the cartilage. During the procedure, the tip of a guide wire used for temporary fixation was previously broken and intentionally left into the distal right humerus, resulting in no interference with fracture's definitive osteosynthesis. Upon fixation, elbow joint was tested in varus/valgus stress under fluoroscopy and found to be stable in both sides. Postoperative radiographic exam confirmed anatomic reduction of the capitellar fractures and the correct hardware positioning (Figs. 1c and 2c). The patient was held in flexion at 90° in a provisionary cast. Starting from the second postoperative day, a functional brace for the elbow was positioned with a free range of motion (ROM) between 100° and 20° of flexion. The hinged brace protected the elbow joint from any varus/valgus deviation stress. No load-bearing or strengthening exercises were allowed until early fracture healing was established, within approximately 2 months after surgery. Upon removal of the sutures at 14 days after surgery, the patient was also allowed to come out of the brace and perform gravity-aided and assisted flexion/extension-supination/ pronation exercises of the elbow joint.
