Arthroplasty Today 1 (2015) 7-10

Case report

Acute, recurrent total knee dislocation: Polyethylene dislocation and malreduction

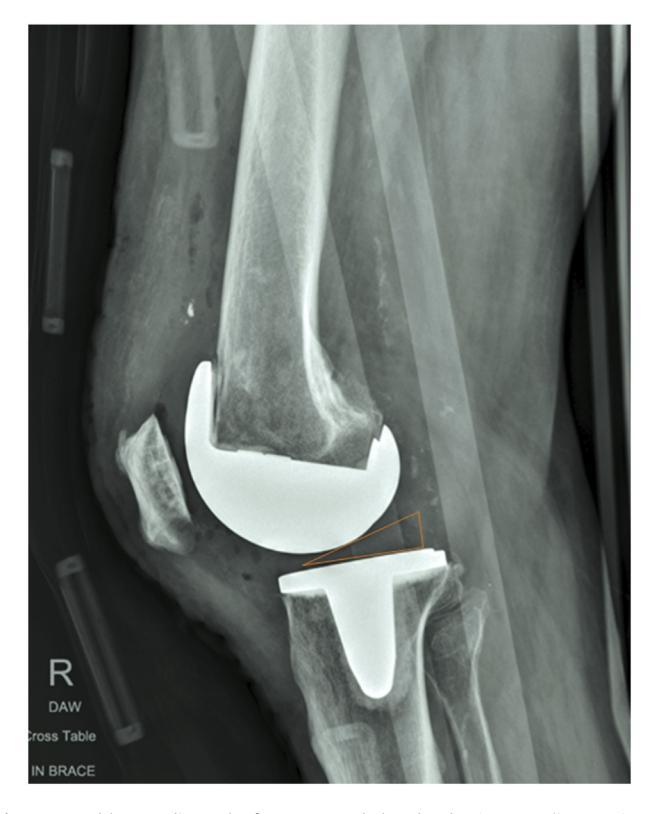
Fig. 1. Lateral knee radiograph after attempted closed reduction revealing persistent subluxation. Outline illustrates the posterior to anterior sloping of the polyethylene insert.

A 62-year-old man with a history of post-traumatic osteoarthritis and associated valgus deformity of the right knee underwent TKA at an outside hospital. Four days post-operatively the patient heard a loud "pop" while getting out of bed; radiographs confirmed posterior dislocation of the right knee. Fluoroscopy-assisted closed reduction was performed under general anesthesia. The patient was immobilized in a brace and made weight bearing as tolerated. Post-reduction radiographs were reviewed when he presented to our institution, which retrospectively showed persistent subluxation (Figure 1).

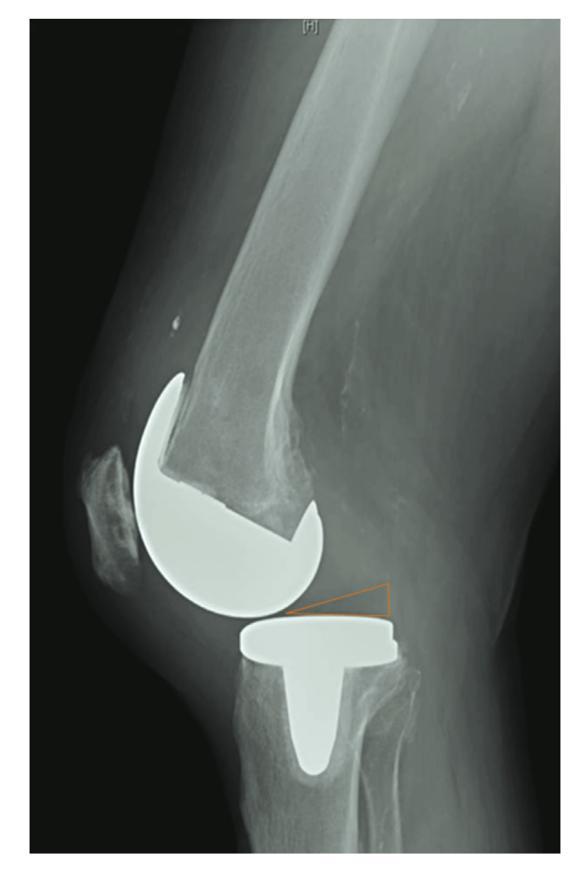
Fig. 2. Lateral knee radiograph at presentation to our clinic revealing posterior dislocation of the tibia. Outline illustrates the posterior to anterior sloping of the polyethylene insert.

Four months afterward, the patient presented to this institution for a second opinion. The patient reported that he had right knee pain and daily dislocations of his right knee. The patient reduced his knee with the aid of traction using a rope tied to a bannister. Radiographs revealed a posteriorly dislocated tibia (Figure 2), and
