# Using Science to Bridge Management and Policy: Terracette Hydrologic Function and Water Quality Best Management Practices in Idaho

By Mark V. Corrao, Barbara E. Cosens, Robert Heinse, Jan U.H. Eitel, and Timothy E. Link

Rangelands 37(5):191–199 doi 10.1016/j.rala.2015.08.003 © 2015 The Society for Range Management

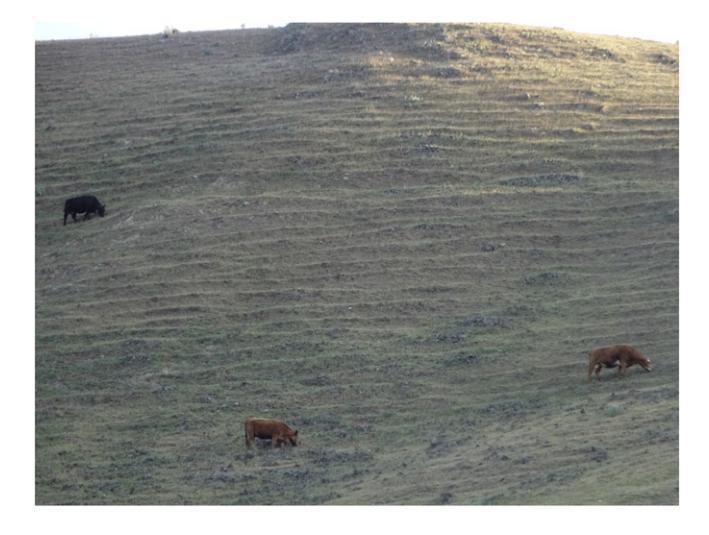
Figure 1. Semiarid rangeland terracettes near Clarkston, Washington, on the north bank of the Snake River, March, 2014 (Photograph by Mark Corrao).

Microtopographic features referred to as "terracettes"<sup>14</sup> are repetitious "bench" (path-like) and "riser," (slope-like) features common in semiarid environments such as those throughout the western United States<sup>15</sup> (Fig. 1). The soil conditions of terracette benches and risers in active pasturelands are often impacted by animal use, resulting in altered vegetative cover and soil compaction.<sup>16</sup> For example, high cattle stocking densities
