# Construction and Building Materials 158 (2018) 346-358

# Performance of different joining techniques used in the repair of bituminous waterproofing membranes

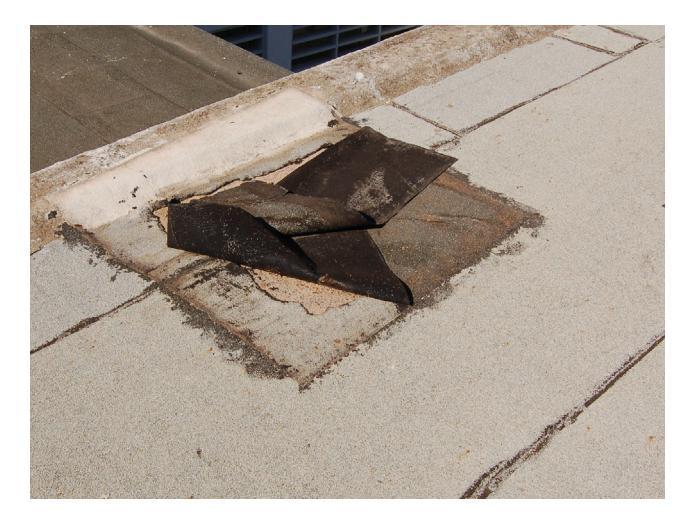
Fig. 1. Example of a failed waterproofing membrane repair.

new waterproofing layers over the damaged areas, which requires the execution of joints between the new membranes and the existing (aged) membranes. For the latter approach, two basic methods are used to join existing (aged) and new membranes: heat welding with a blowtorch and adhesive bonding. The use of the correct repair techniques and of compatible materials are essential to the effectiveness of the repair. Fig. 1 shows an example of an unsuccessful repair carried out on a damaged waterproofing membrane, illustrating how poor adhesion in the joints between the new and the existing membranes can result in failure of the repair.
