## Optics and Laser Technology xxx (2017) xxx-xxx

# The effect of laser surface melting on microstructure and corrosion behavior of friction stir welded aluminum alloy 2219

# Shengchong Ma, Yong Zhao\*, Jiasheng Zou, Keng Yan, Chuan Liu

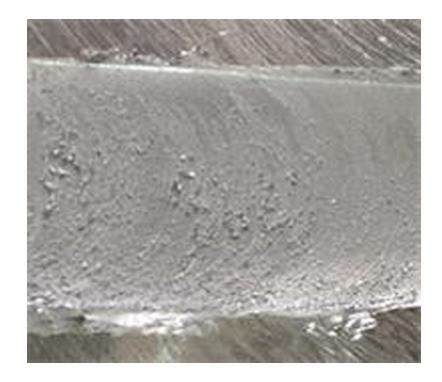
Fig. 1. As-processed friction stir weld of AA 2219.

Fig. 1 shows the appearance of friction stir welded joint of AA 2219. It can be seen that sound weld without obvious defects was obtained when rotation speed was 1000 rpm and travel speed was 100 mm/min. The joints were cross-sectioned perpendicular to the welding direction for microstructure analyses. The cross-sections of the metallographic specimens were observed by optical microscopy after etching with Keller's reagent (1 mL of HF + 1.5 mL of HCl + 2.5 mL of HNO<sub>3</sub> + 95 mL of distilled water).
