Surface & Coatings Technology

Failure analysis of fine-lamellar structured YSZ based thermal barrier coatings with submicro/nano-grains

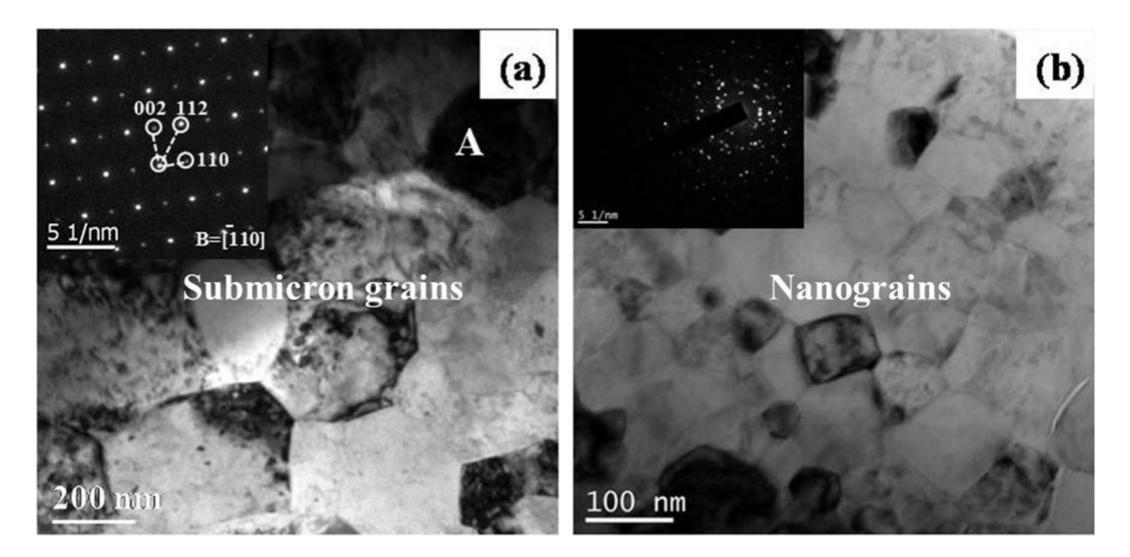
Fig. 1 shows the TEM images of as-sprayed YSZ coating. As seen from Fig. 1a, many polyhedron-shaped grains with an average size of 250 nm were observed after the fusion and recrystallization of the original feedstock powder. The selected area electron diffraction (SAED) patterns

Fig. 1. TEM images of (a) submicron grains and (b) nanograins in the as-sprayed coating.
