Case Report

A case of transnasal intracranial penetrating injury with skull base fracture caused by a broken golf club shaft

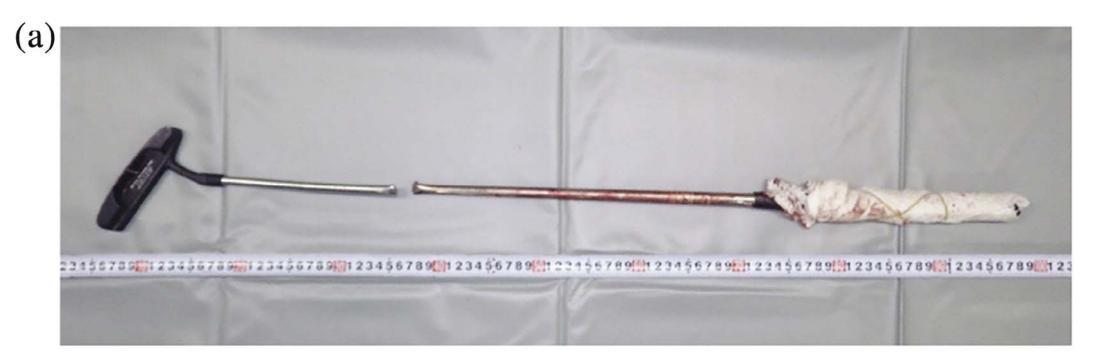
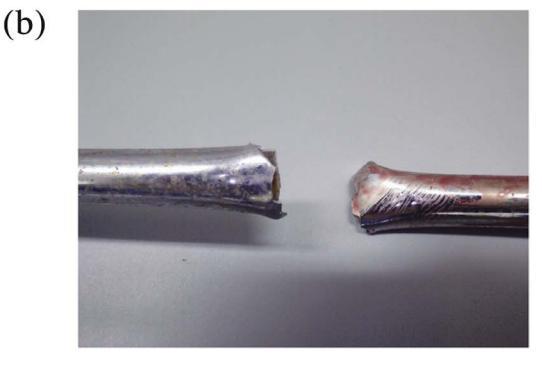
Fig. 1. The broken golf club shaft, with blood, used as a weapon. a) entire golf club b) enlarged photograph of the top. The shaft was fractured at the one-third distal position. A towel was wrapped around the grip by the perpetrator so as not to slip during striking. The diameter of the broken point of the shaft was 0.9 cm. The top of the broken shaft was sharp.

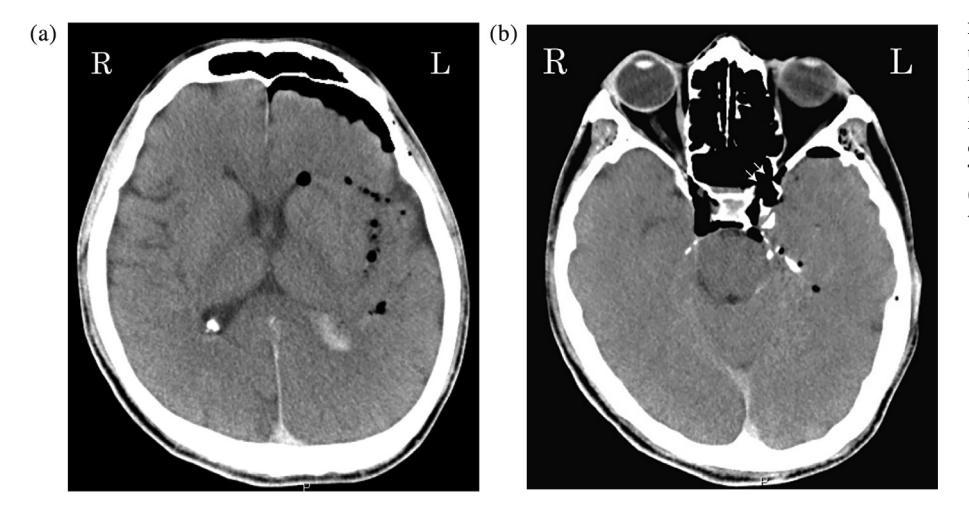
Fig. 2. Postmortem CT scan of transverse section through the brain. a) Intracranial air was observed in the frontal horn of the left lateral ventricle, the left sylvian fissure, and the subdural space in front of the left frontal lobe. A high intensity area indicating subarachnoid hemorrhage was observed in the inferior horm of the left lateral ventricle. b) The left posterior wall of the sphenoid sinus was fractured (white arrow). The region is located just to the left cavernous sinus.

from a little away immediately called an ambulance, however, the victim died during transport to hospital. Postmortem CT revealed pneumocephalus (Fig. 2a), massive fluid collection in the main bronchus, and a crush fracture in distal part of the left radius. Postmortem CT also revealed fracture of the left posterior wall of the sphenoid sinus (Fig. 2b). However, a definitive cause of death was not identified.
