Building and Environment 104 (2016) 208-220

Moisture dynamics in the masonry fabric of historic buildings subjected to wind-driven rain and flooding

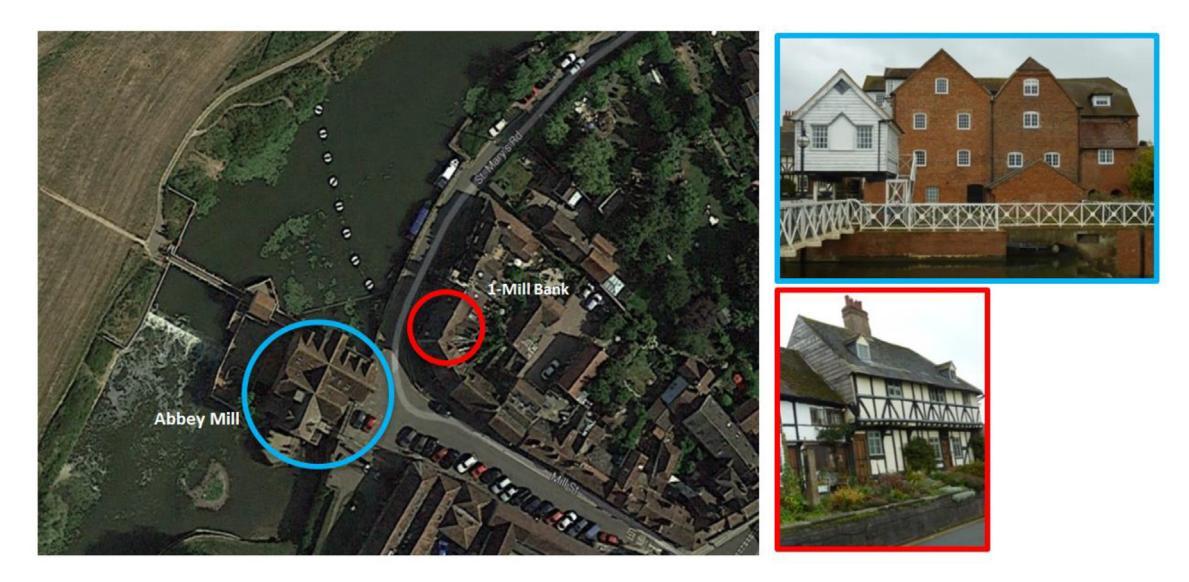
Fig. 1. Aerial view showing the site, and the north-western elevations of Abbey Mill and 1-Mill Bank, respectively.

This paper presents the environmental monitoring system developed for this purpose and discusses the hygrothermal characterization work carried out with respect to two historic buildings in Tewkesbury (Gloucestershire, England) (Fig. 1). Tewkesbury is an early medieval town founded at an elevation of approximately 15 m above sea level at the confluence of the River Avon and River Severn, chosen for its exposure to floods, the earliest recorded incident being in 1484 [22,23]. In the last decade the most intense flood event causing widespread damage in Tewkesbury was recorded in July 2007 [24], with associated costs in the range of £3.2 billion [25]. The May 2012 events caused flooding at the site of interest with estimated costs £600 million nationwide [26], whilst this value is much higher for 2015 floods [27]. [1] report predicts that southwest England will have substantial seasonal changes in precipitation in the next 50 years [1]. Tewkesbury is therefore highly representative of a location with long history of exposure of its building stock to critical events and of future heightened hazards. Of the two buildings reported here, Abbey Mill is a Grade II listed, 4 storey brick masonry building from the late 18th century, built on foundations that are considered to be from the early 12th century. It is located next to the River Avon leat adjacent to a wide flood plain, at the bottom of Mill Street. The second building, 1-Mill Bank is a 16th century 2 storey oak timber frame cottage with brickwork infill, also Grade II listed, located on raised ground on the bank of the River Avon, right across the road from the Abbey Mill. Both buildings whose use is currently residential, are known to have been in use throughout their lives and in a good state of conservation with functioning drainage and roofs and no visible structural distress.
