#### Construction and Building Materials 171 (2018) 128-139

# Characterisation of old *azulejos* setting mortars: A contribution to the conservation of this type of coatings

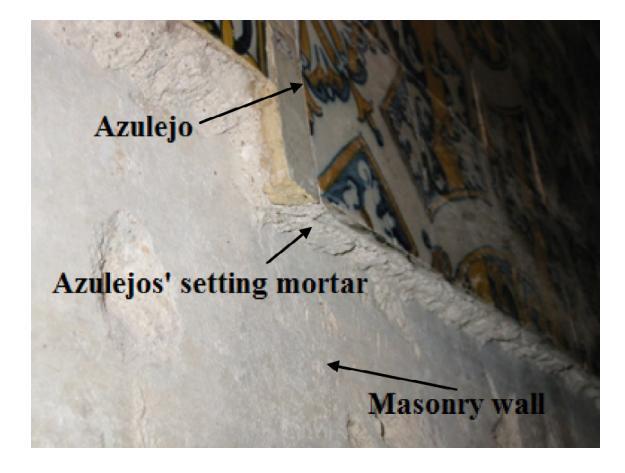
Fig. 2. Azulejos coating system.

In these old coatings, the mortar is the bond between the substrate and the *azulejo* itself; so its behaviour directly influences the system as a whole (Fig. 2).
