Construction and Building Materials 124 (2016) 1109-1119

Yang Tang^a, Guobin Xu^{a,*}, Jijian Lian^a, Hui Su^b, Chunlai Qu^b

A novel test control system is used to assess the effects of temperature and humidity on the adhesion strength of shotcrete-surrounded rock. Analysis of the internal structure and defect volume reveals that the adhesion strength increases with relative humidity (RH), whereas higher temperatures and longer setting times increase the risk of shotcrete dehydration through an increase in porosity. The critical temperature at which adhesion strength is lost also increases with RH. This shows that temperature, RH and setting time all greatly influence the adhesion strength of shotcrete-surrounded rock, which is of relevance to diversion tunnel construction in highly geothermal environments.

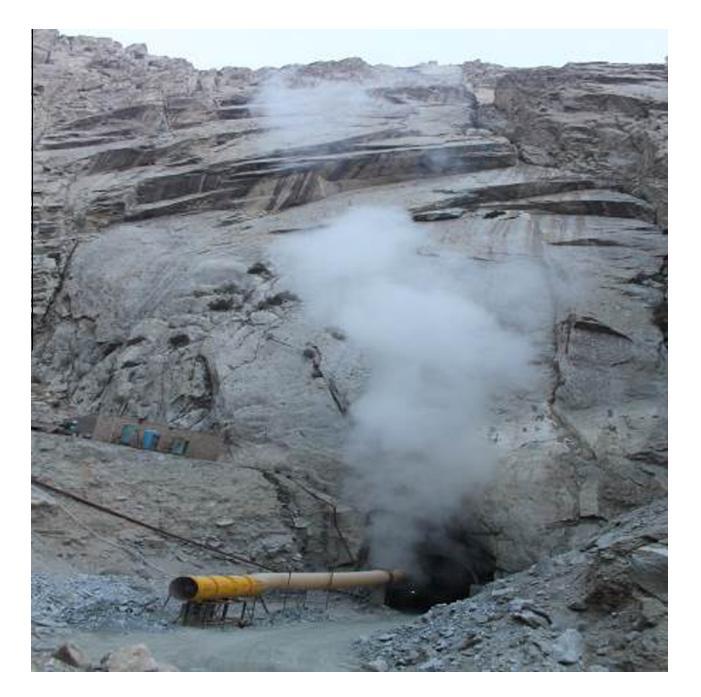
Fig. 1. Water vapour gushing into the entrance.

Qirehataer Hydropower Station is located near the Tashikuergan River, and lies within the Tashikuergan Tajik Autonomous County of the Xinjiang Uygur Autonomous Region. Its diversion tunnel passes through a highly geothermal environment between Y7 + 010 and Y10 + 355, which has resulted in water vapour gushing into the entrance of the tunnel during construction owing to the high temperature in the main hole (Fig. 1). This geothermal zone has an overall length of 3345 m and consists of rock classified as gneissic granite. At present, the tunnel temperature and humidity tend to be stable, with the variation being either seasonal or the result of tunnel ventilation. Monitoring data for the surrounding rock indicates that the highest temperature in the tunnel was >60 °C, and that the lowest relative humidity (RH) was 25%. Based on this data, the working conditions selected for testing were a RH of 25 or 90%, and a temperature of 50, 60, 75, or 90 °C (Table 1).
