Engineering Structures

The influence of environmental parameters on the dynamic behaviour of the San Frediano bell tower in Lucca

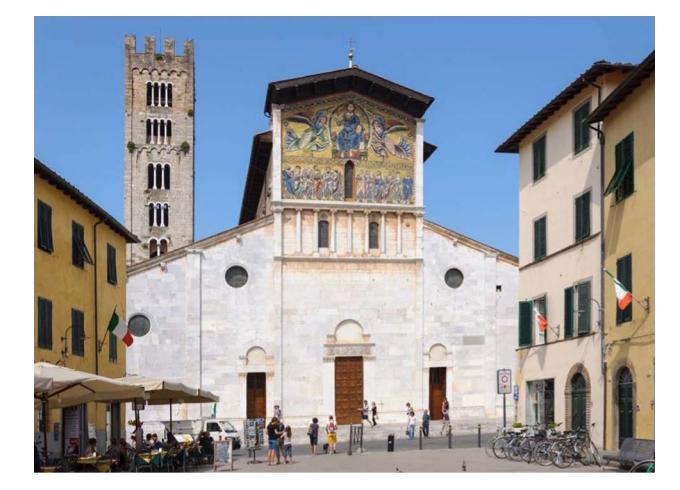
Fig. 1. The Basilica of San Frediano in Lucca (Italy). On the left, the San Frediano bell tower.

The Basilica of San Frediano (see Fig. 1) dates back to the 11th century. It is one of the most fascinating monuments in Lucca, much of its fascination being due to the marvellous mosaics that adorn its facade, which glistens spectacularly in the light of the rising sun. The church's bell tower is one of the best preserved in Lucca's historic centre. It is 52 m high, with walls varying in thickness from about 2.1 m at the base to 1.6 m at the top. The tower is entered through a masonry staircase leading from the street level to the first floor, which is formed by a masonry vault set at a height of about 8.6 m (Fig. 2). From this level, a stone staircase running along the inner perimeter provides access to the terminal section of the tower, about 40 m high, which houses the bells. The bell chamber is separated from the rest of the structure by a stiff masonry vault, which has been fitted with 4 steel tie rods of rectangular section. Over the vault, at about 43 m, there is a walkable wooden floor, which makes it possible to reach the bells. No rigid diaphragms are present inside the tower between the two vaults: the structure's section is not stiffened for about 30 m's height. The tower bears openings on all sides and is covered by a pavilion roof made up of wooden trusses and rafters in a very poor state of maintenance. The San Frediano Basilica adjoins the tower on two sides for about 13 m of its height. Although little information is available on the history of the bell tower, the numerous modifications made to the structure over time are clearly visible. In particular, the upper part of the structure, now hosting the bell chamber, seems to have been built later than the rest of the structure. The same appears for the bifora and trifora windows along the tower. With regard to the mechanical characteristics of its constituent materials, no experimental information is available at the moment. On visual inspection, the masonry seems to be made up of regular stone blocks at the base, while quite homogeneous brick masonry is visible in the upper section, apart from the central part of the walls, where the masonry between the windows is made up of stone blocks.
