Soil Dynamics and Earthquake Engineering

Seismic risk mitigation of cylindrical electrical equipment with a novel isolation device

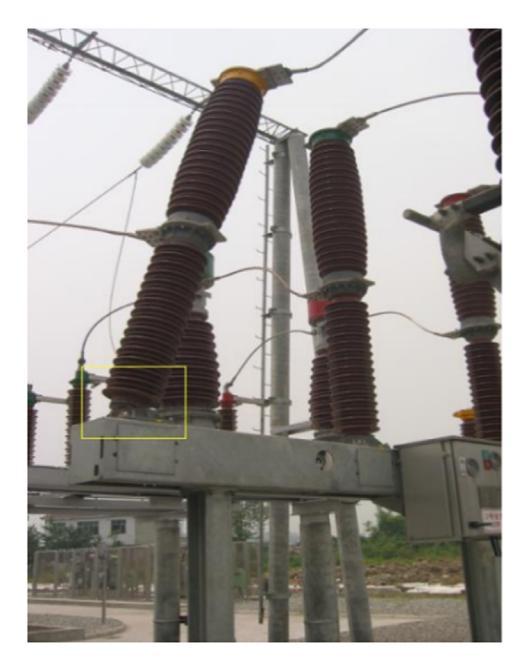
Fig. 1. Failure of cylindrical electrical equipment in 2008 Wenchuan Earthquake [8].

Substations are important nodes in electrical grids, which are a complex of electrical equipment in various types. The seismic fragility of substation equipment has attracted attention after many earthquakes, such as 2008 Wenchuan Earthquake [5] (as seen in Fig. 1) and 1994 Northridge Earthquake [6]. Due to requirement on electrical functionality, the material adoption and structural type are usually similar for a kind of equipment in different voltage levels. However, the structural scale of equipment in a higher voltage level can be significantly larger. In the substation, a 1000 kV surge arrester can reach 13 m in height and 9 t in weight, which is nearly 2 times taller and 5 times heavier than a 500 kV surge arrester [7]. It results in much larger earthquake induced forces, making it more challenging to achieve seismic safety.

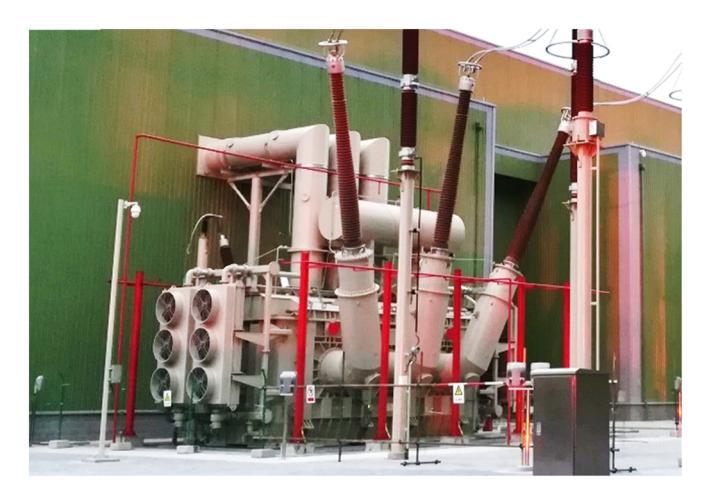
Fig. 2. Electrical transformer installed in \pm 800 kV Zhalute Convertor Substation in Inner Mongolia, China.

Isolation technology is an effective method for seismic mitigation of substation equipment, especially for two main kinds of them. One is the isolation of bulky equipment such as electrical transformer and shunt reactor, as seen in Fig. 2. This kind of equipment has large equipment body at base and flexible bushing installed in vertical or tilt direction at top. The other is the isolation of cylindrical equipment in slender shape, as seen in Fig. 3. This kind of equipment is an assembly of insulator units and often installed on supporting structure in vertical direction. A substation contains large number of the slender cylindrical equipment,

For electrical transformers as seen in Fig. 2, seismic isolation is aimed at reducing responses of bushing [9] and avoiding excessive acceleration or overturning of equipment body [10]. Base isolation systems in different types have been used and proved to be efficient. For isolation in horizontal direction, Saadeghvaziri et al. [11] and Oikonomou et al. [12] installed friction pendulum system for reducing the seismic responses of the transformer. Cheng et al. [13]. Murota et al. [14] and Oikonomou et al. [12] have adopted Lead Rubber Bearing (LRB) for reducing response of the transformer body and bushing. It was pointed out by Lee et al. [15] that for the common seismic isolation technique of electrical transformer, vertical ground motions were transmitted through the isolation system unchanged or even magnified. Probabilistic seismic assessment carried out by Kitayama et al. [16,17] proved that systems which were isolated in both horizontal and vertical directions can be further effective in enhancing the reliability of transformer. Lee et al. [15,18] designed a novel horizontal-vertical seismic isolation system for the electrical transformer, which was a combination of two separate systems, friction pendulum isolators to achieve horizontal seismic isolation and spring damper units to achieve vertical seismic isolation. Shaking table test validation of the system showed it was effective and reliable.

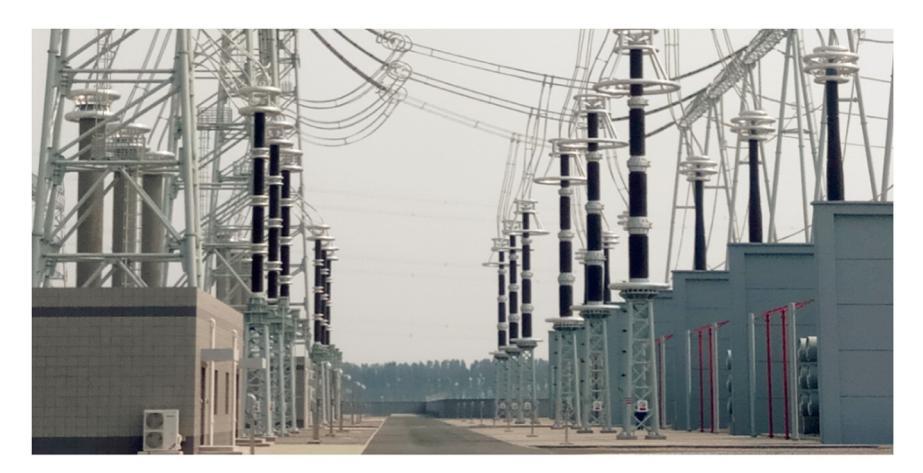
Fig. 3. Cylindrical electrical equipment in 1000 kV Beijing East Substation in Beijing, China.

For cylindrical equipment in slender shape as seen in Fig. 3, the failure of this kind of equipment was repeatedly observed in earthquake events in form of insulator facture [5,19], indicating that flexural moment at bottom was key for seismic safety [20]. The seismic isolation technique for this kind of equipment has not been fully studied, and it is the main object of this paper. Alessandri, et al. [21,22] introduced an application of wire rope isolators to form a base isolation system. It took advantage of flexibility and friction between the wires to provide mechanical isolation properties. In that system, reducing the stress of electrical equipment would result in larger displacement of superstructure in wind load, so that a balance should be met to avoid displacement induced problem. It is an intention of this paper to introduce and validate a novel isolation system for slender cylindrical equipment which has excellent mitigation effect on seismic responses, while keeping the structural rigidity unchanged in operational load such as wind. On the other hand, cylindrical electrical equipment of different dynamic properties needs to be connected with each other by conductor buses or cables to form circuits of different functionalities. If displacement at the top of equipment is too large, slackness of the conductor between equipment might be not adequate and significant dynamic interaction may occur and cause damages [23,24]. Many researches
