Applied Acoustics 87 (2015) 212-218

An experimental analysis of the correction factors adopted on environmental noise measurements performed with window-mounted microphones

Keywords: Environmental noise Facade correction factors Long-term assessment

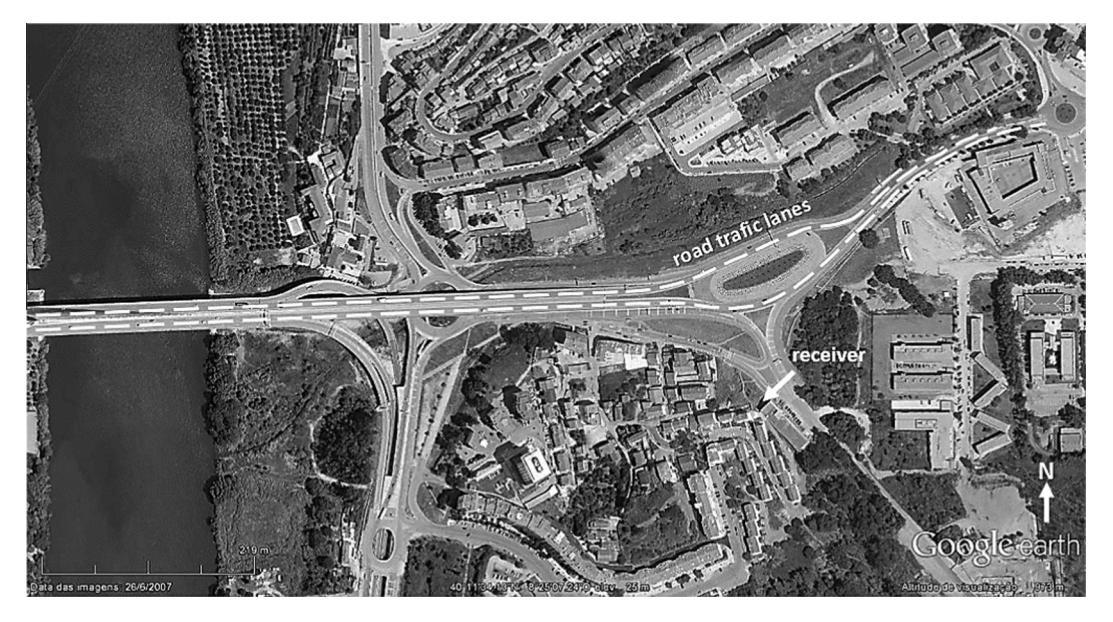
Fig. 1. Aerial view of the studied area, identifying the main traffic route.

The surrounding area is transversally crossed by a traffic lane of relative importance, which is indicated in Fig. 1 by the white dashed lines. This road has two lanes in each direction, having traffic quite fluid and an average daily rate (ADR) of approximately 37,000 vehicles per day, with approximately 10% of heavy vehicles. The traffic is mostly fluid and decelerating, in the west–east direction, from 70 km/h, over the bridge, to 50 km/h, after the bridge. In the east–west direction, the traffic is also fluid and accelerates from 50 km/h to 70 km/h.
