2nd International Conference on Structural Integrity, ICSI 2017, 4-7 September 2017, Funchal, Madeira, Portugal

Numerical Analysis of Bird Strike Resistance of Helicopter Searchlight

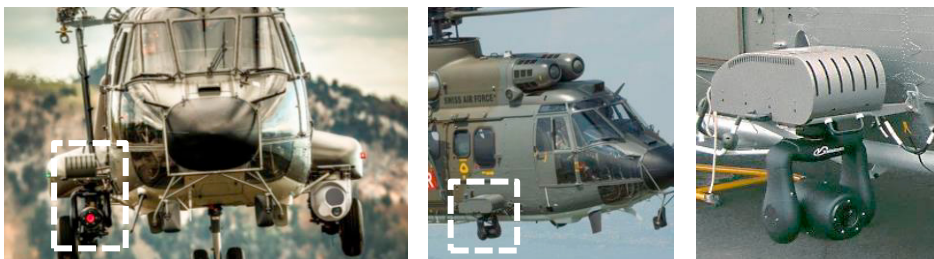
Fig. 1. Swiss Air Force Super Puma helicopter with highlighted external searchlight (photo copyright & permission: VBS).

The focus of this current study is on the external searchlight that was developed by RUAG in the framework of the TH06 ISR upgrade of the AS 322 Super Puma helicopters of the Swiss Air Force (Fig. 1). While the searchlight itself is a third-party component, the searchlight pod, which is attached to the helicopter airframe and houses the electronic components is a development of RUAG. Since the customer requires the demonstration of bird strike resistance according to FAR/CS 29 of this component, a numerical analysis study was conducted to simulate the bird strike loading at different relevant impact positions.
