Original article

The scientific approach to the restoration and monitoring of mural paintings at S. Girolamo Chapel – SS. Annunziata Church in Florence

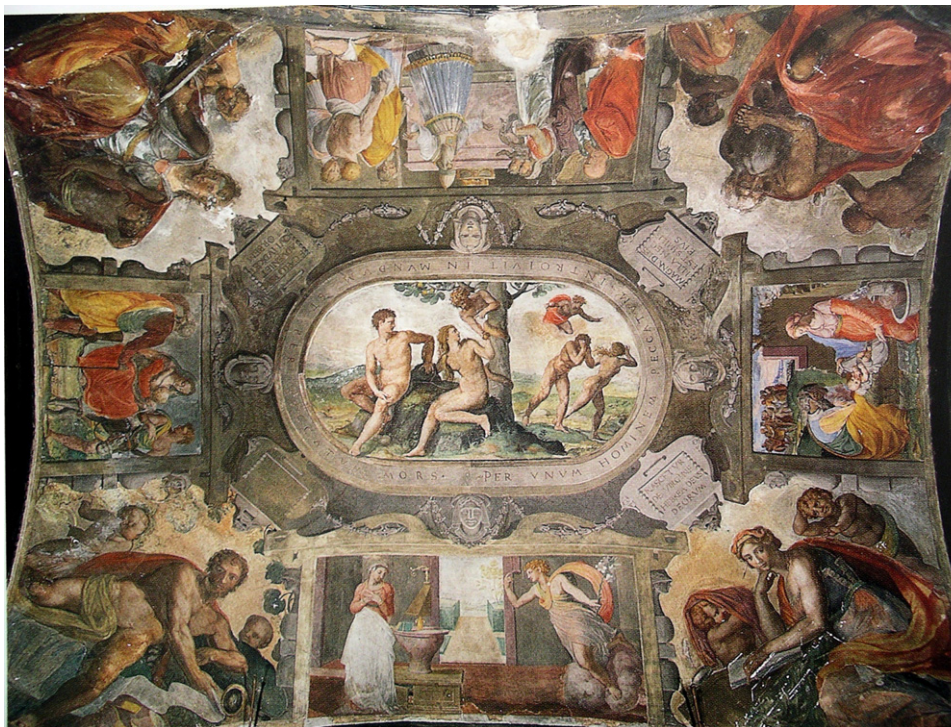
Fig. 1. The paintings on the vault after the restoration.

The frescoes represent The Expulsion from the Garden of Eden on the vault (Fig. 1), Prophets and Sybils on the
