A parametric study on friction-loss in water conveyance tunnels considering misalignment of precast concrete segments

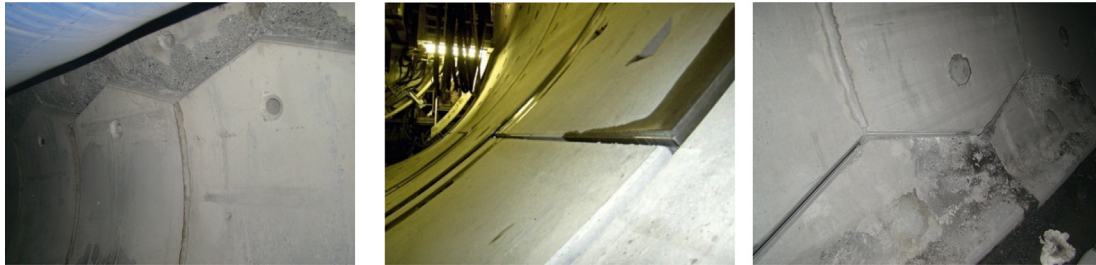
Fig. 1. Examples of concrete segment misalignments in different parts of tunnel lining.

misalignment between lining segments and rings (King, 2006; Mayer et al., 2009). On the hand, it is also common to use the lining segments without any bolts or dowels (using joints such as tongue and groove or knuckle and hinged). Furthermore, details of tunnel construction like horizontal or vertical curve in tunnel path and segment geometry can affect the application of dowels or bolts (Arнау and Molins, 2012). Specifically, in universal or tapered ring segments, it is usual to use the sockets such as dowel and bolts; while hexagonal segments does not include socket systems. In tunnels constructed with hexagonal segments which dowels or bolts cannot be used, large segment misalignments have been observed (Maidl et al., 2012). Even in tunnels with universal or tapered ring segments, it is possible that the dowels and bolts fail due to bad geological conditions and sub-surface problems and also large steps occur. In Fig. 1 some examples of tunnel lining misalignment are shown. As shown in this figure, misalignments can occur in different parts of tunnel lining such as invert, side, and top segments.
